the **play inspection** company

Annual Inspection

Wexham Court Parish Council

Norway Drive Recreation Ground

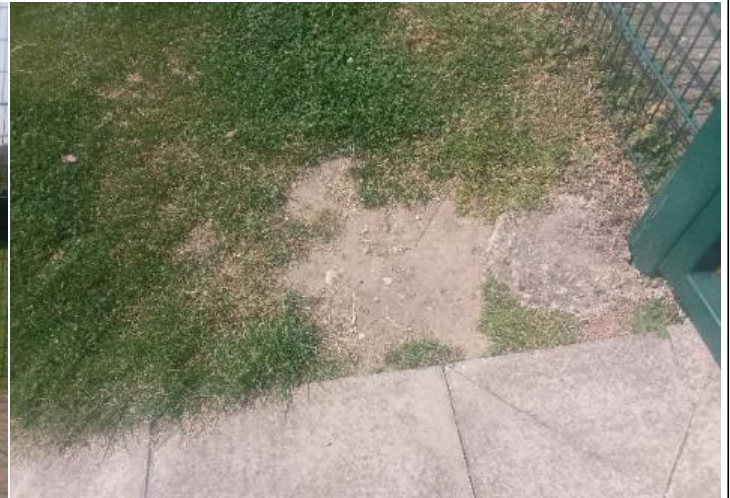
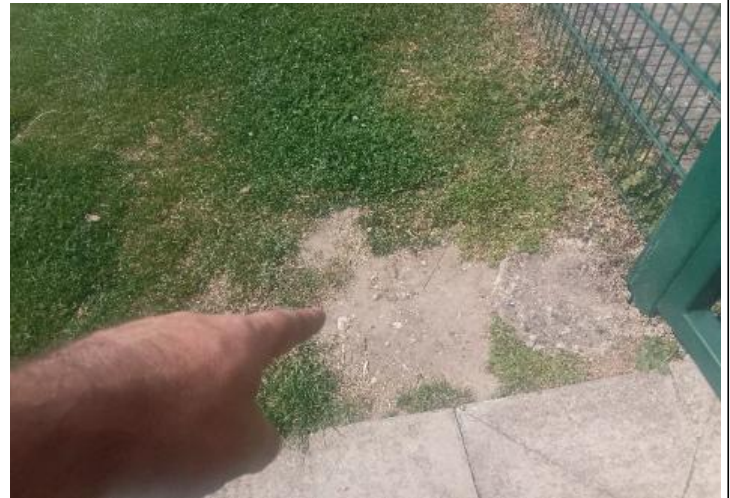
Item: Gates - Gate - Self Closing
Manufacturer: Not Identified

The area under the gate has eroded leaving uneven areas, or the concrete foundations exposed, resulting in trip hazards at the entrance/exit to the playground - Reinstate to level with surrounding surfaces

Finding: The area under the gate has eroded leaving uneven areas, or the concrete foundations exposed, resulting in trip hazards at the entrance/exit to the playground

Action: Reinststate to level with surrounding surfaces

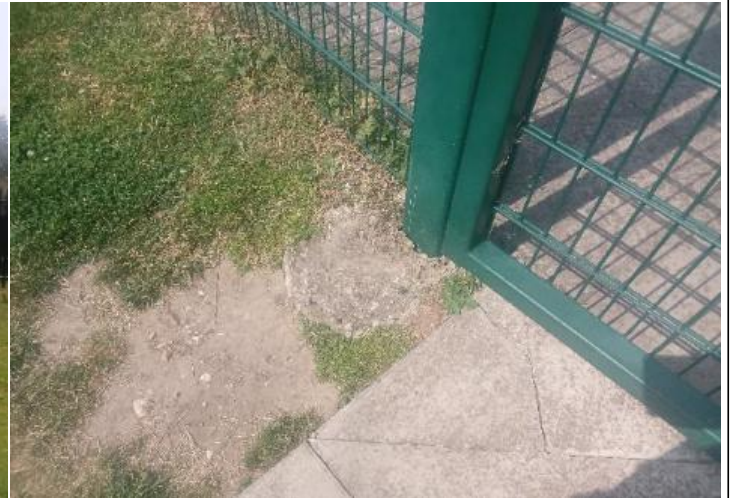
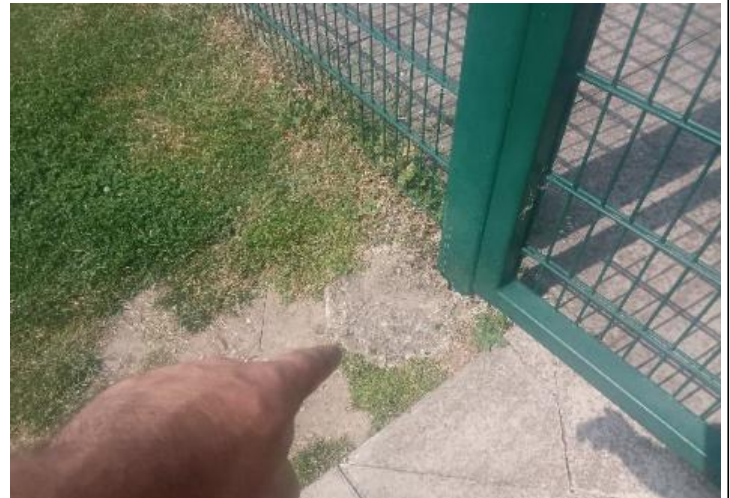
Item: Fences - Fence - Steel Mesh
Manufacturer: Not Identified

The surface has eroded and the foundations are exposed - Reinstate surrounding surfaces to cover the foundations

Finding: The surface has eroded and the foundations are exposed

Action: Reinststate surrounding surfaces to cover the foundations

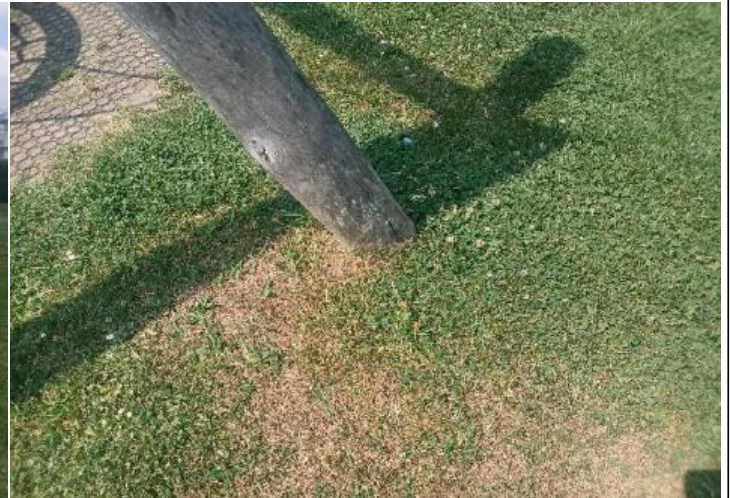
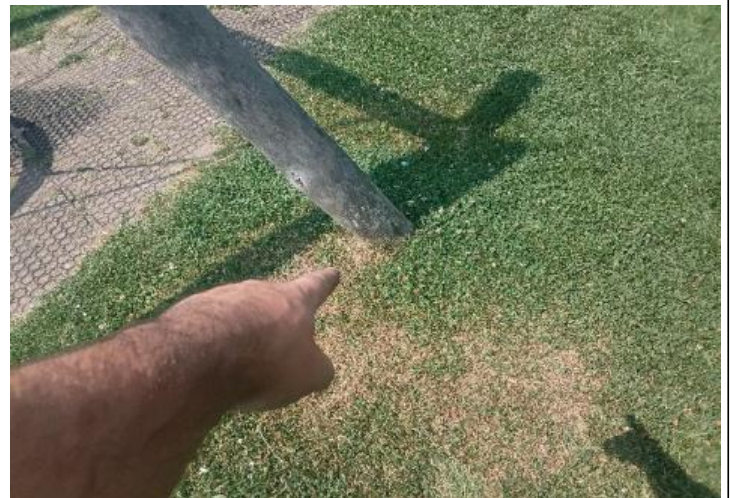
Item: Swings - 1 Bay Swing
Manufacturer: Kompan Ltd

There is some strimmer / machinery damage apparent on the posts, this can penetrate the preservative applied to the timber and accelerate the rotting process - Monitor for any deterioration (rot) and replace as required

Finding: There is some strimmer / machinery damage apparent on the posts, this can penetrate the preservative applied to the timber and accelerate the rotting process

Action: Monitor for any deterioration (rot) and replace as required

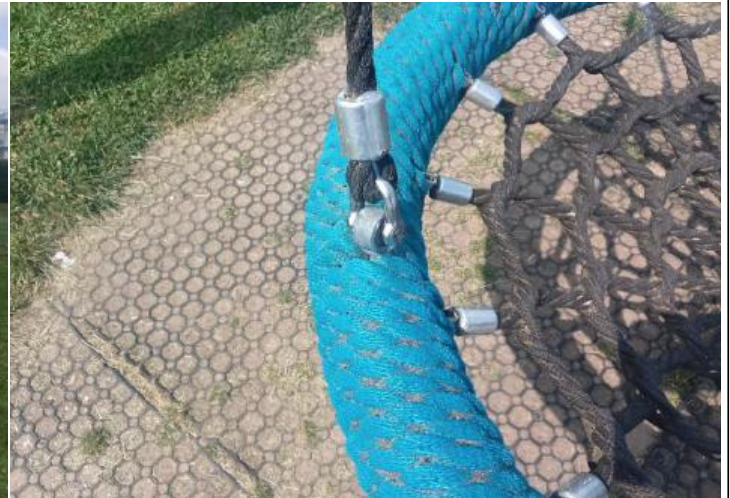
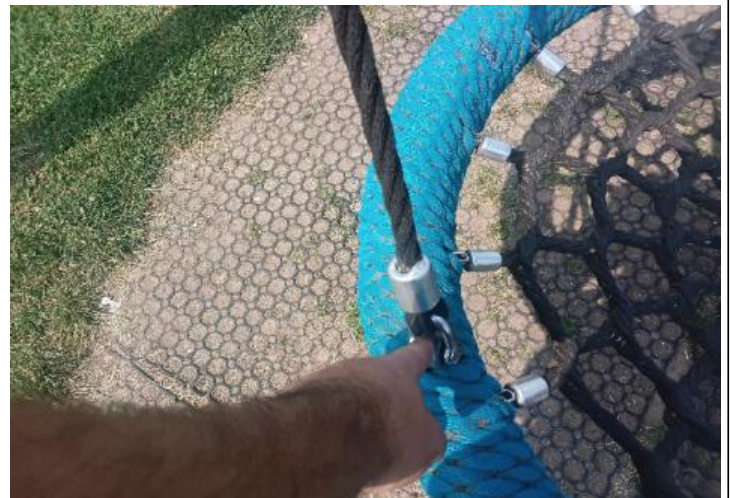
Item: Swings - 1 Bay Swing
Manufacturer: Kompan Ltd

The bushes are showing signs of wear - Monitor for any further deterioration and replace as required

Finding: The bushes are showing signs of wear

Action: Monitor for any further deterioration and replace as required

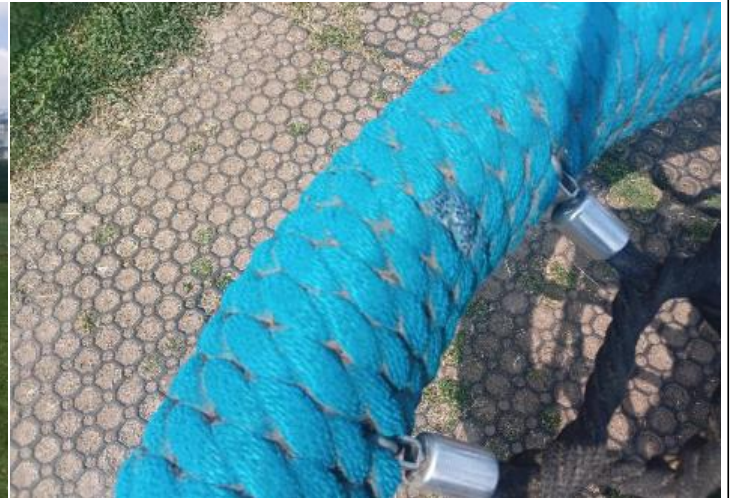
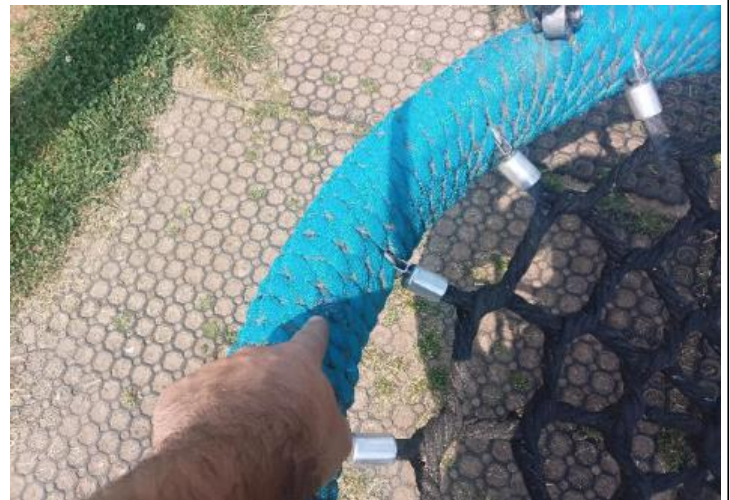
Item: Swings - 1 Bay Swing
Manufacturer: Kompan Ltd

There is some evidence of fire damage to the item - Monitor for any further deterioration and repair as required

Finding: There is some evidence of fire damage to the item **Action:** Monitor for any further deterioration and repair as required

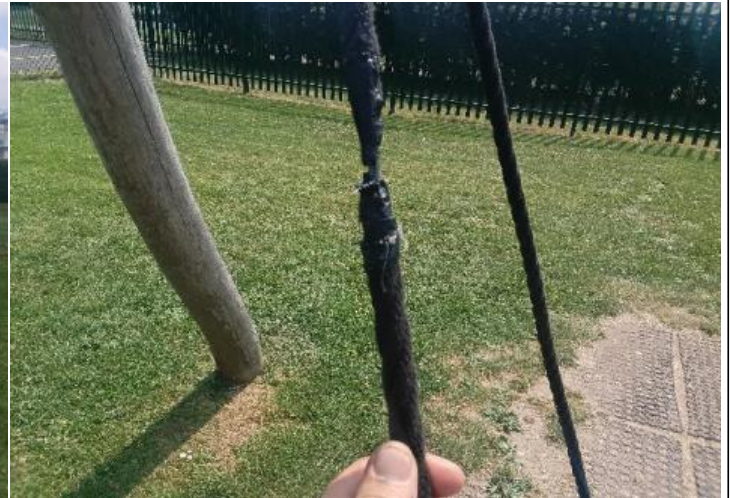
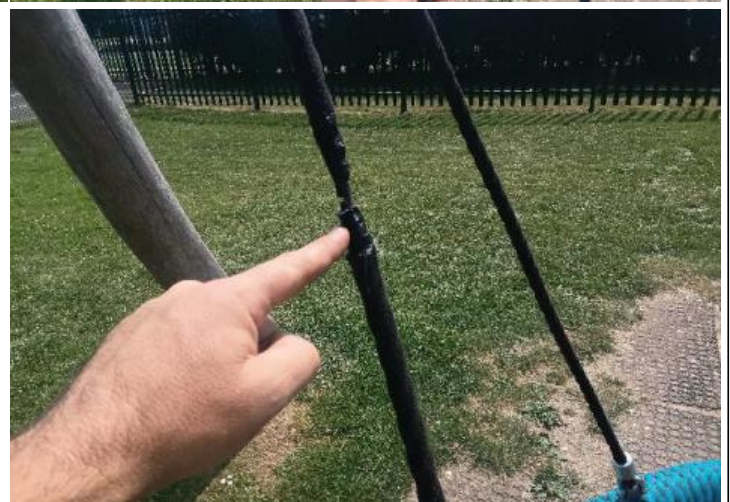
Item: Swings - 1 Bay Swing
Manufacturer: Kompan Ltd

The ropes on this item have been taped and we are unable to fully assess the condition of the rope, ensure no wire strands are broken beneath the tape - Repair or replace as required

Finding: The ropes on this item have been taped and we are unable to fully assess the condition of the rope, ensure no wire strands are broken beneath the tape

Action: Repair or replace as required

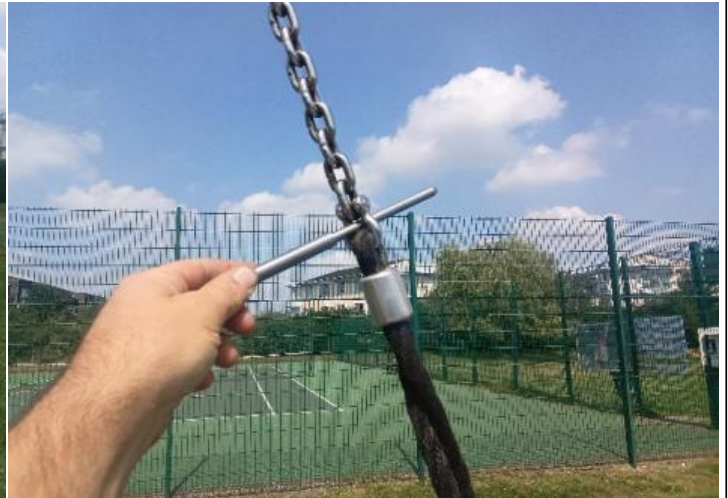
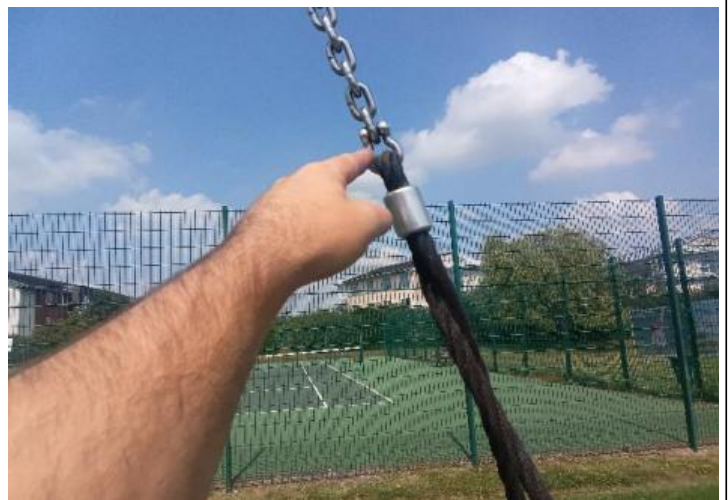
Item: Swings - 1 Bay Swing
Manufacturer: Kompan Ltd

The connecting links are in excess of 8.6mm and less than 12mm and fail the requirements of BS EN 1176 Part 1; clause 4.2.13, Chains - Monitor - No remedial work recommended

Finding: The connecting links are in excess of 8.6mm and less than 12mm and fail the requirements of BS EN 1176 Part 1; clause 4.2.13, Chains

Action: Monitor - No remedial work recommended

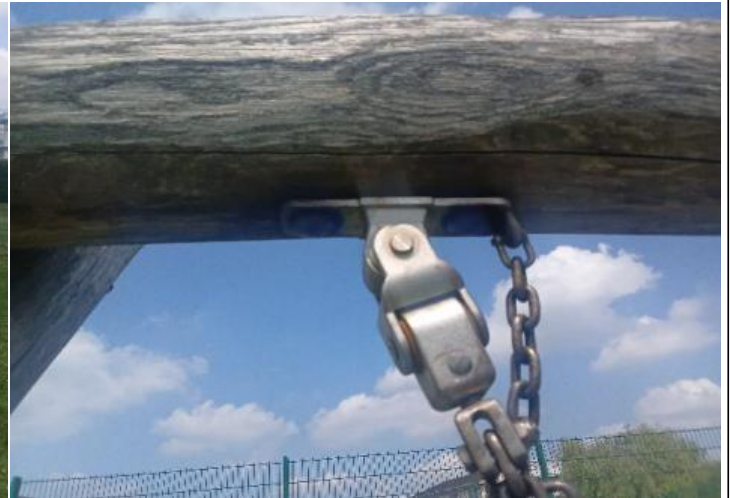
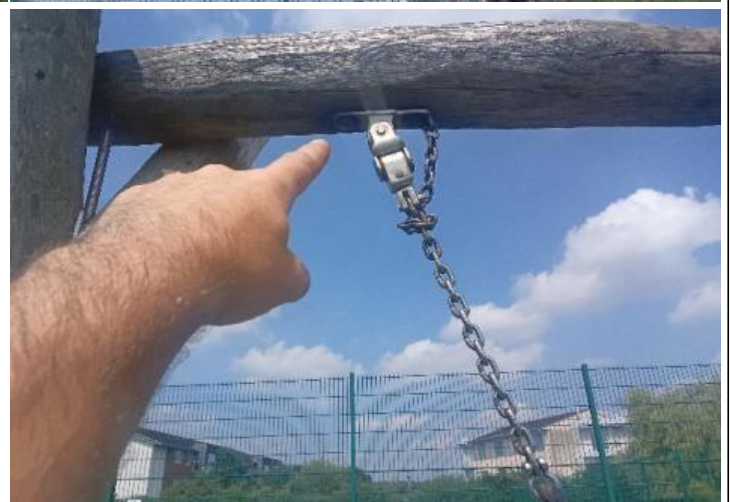
Item: Swings - 1 Bay Swing
Manufacturer: Kompan Ltd

A number of fixing(s) have worked loose - Secure all loose fixings

Finding: A number of fixing(s) have worked loose

Action: Secure all loose fixings

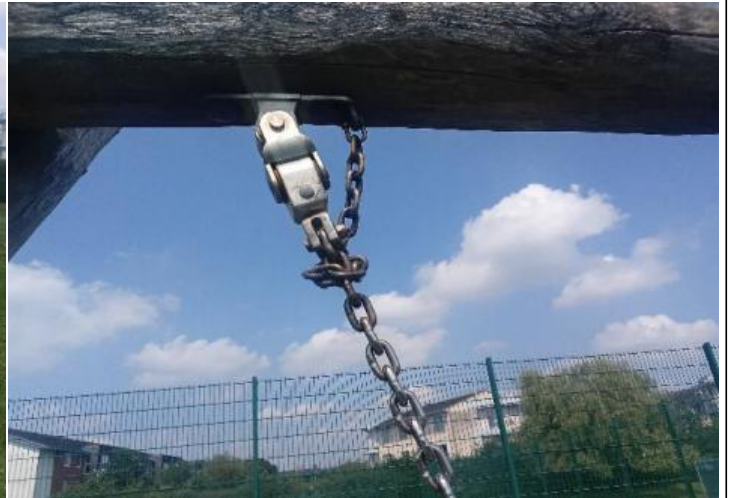
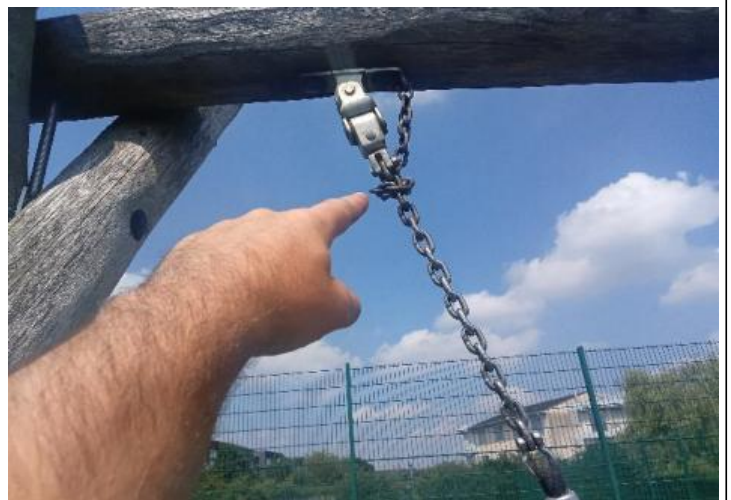
Item: Swings - 1 Bay Swing
Manufacturer: Kompan Ltd

The swivel joint fixings are very loose - Retighten fixings

Finding: The swivel joint fixings are very loose

Action: Retighten fixings

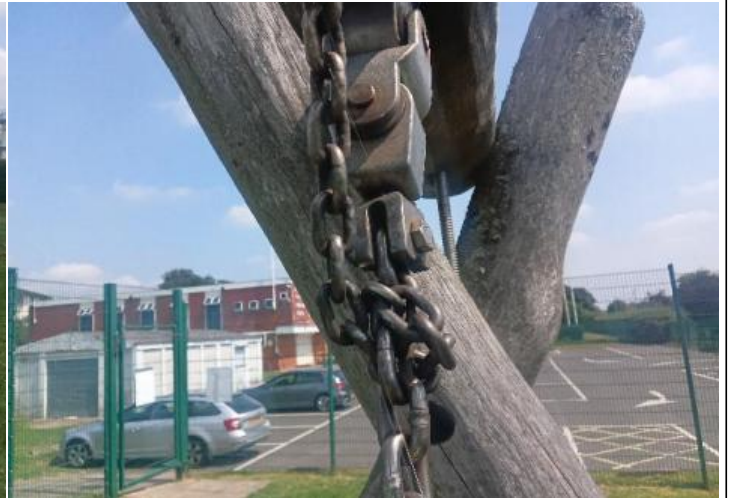
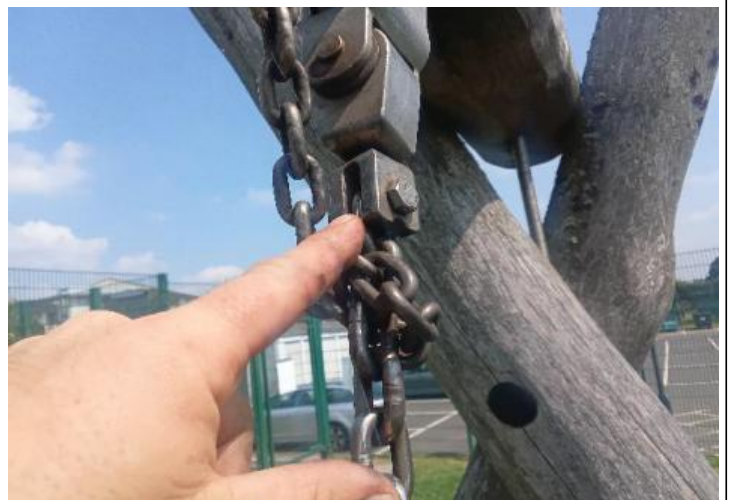
Item: Swings - 1 Bay Swing
Manufacturer: Kompan Ltd

There is some notable evidence of chain wear - Monitor for any further deterioration and replace when 40% worn

Finding: There is some notable evidence of chain wear

Action: Monitor for any further deterioration and replace when 40% worn

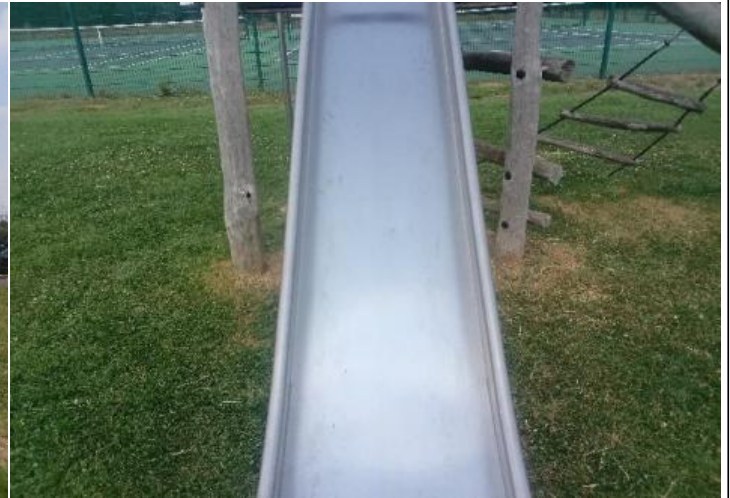
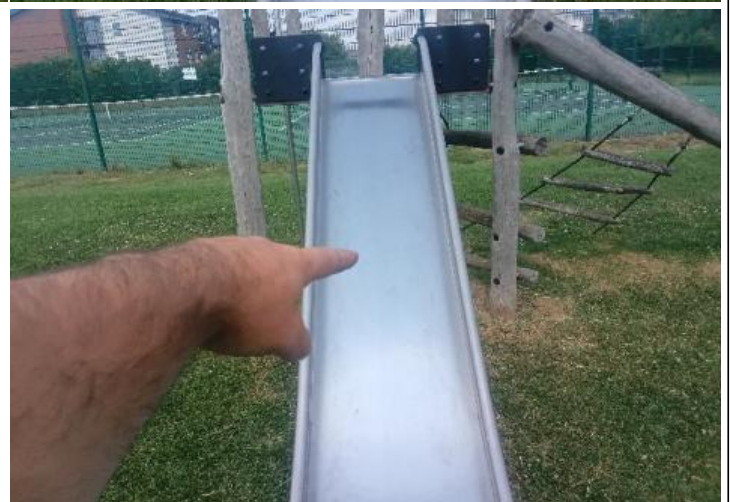
Item: Activity Equipment - Activity Platforms
Manufacturer: Kompan Ltd

There are a number of dents in the slide surface - Monitor for any further deterioration and repair as required

Finding: There are a number of dents in the slide surface

Action: Monitor for any further deterioration and repair as required

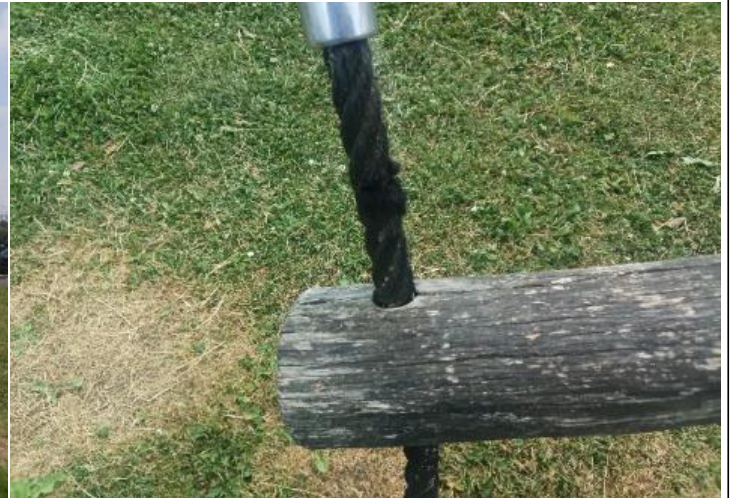
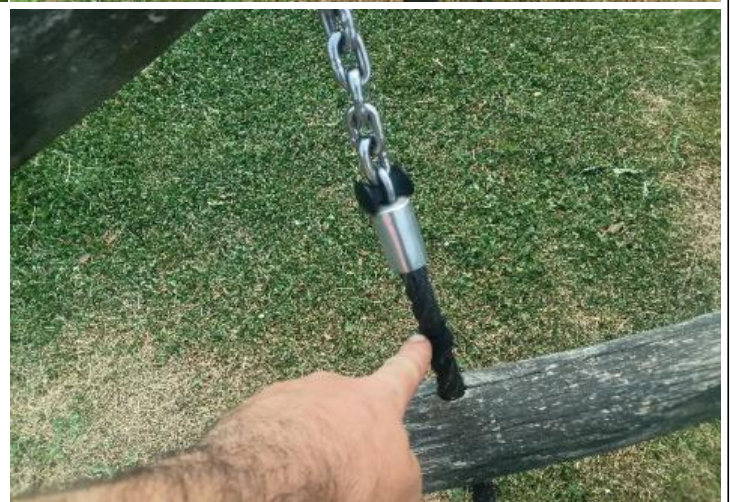
Item: Activity Equipment - Activity Platforms
Manufacturer: Kompan Ltd

The ropes/nets are worn/damaged in places - Monitor for any further deterioration and repair or replace as required

Finding: The ropes/nets are worn/damaged in places

Action: Monitor for any further deterioration and repair or replace as required

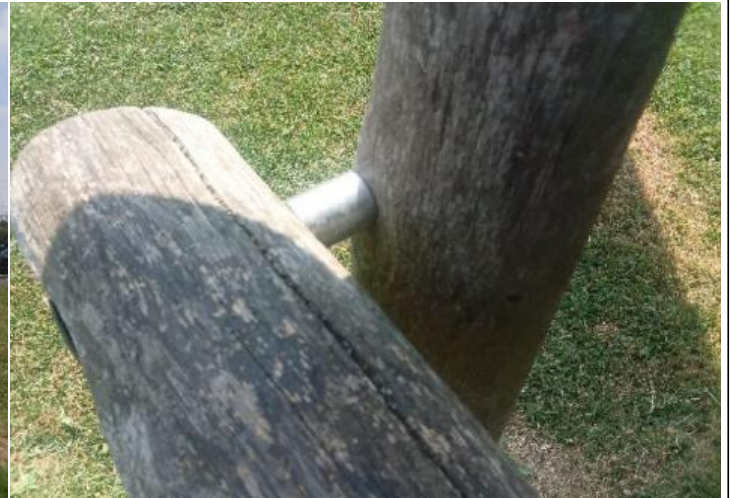
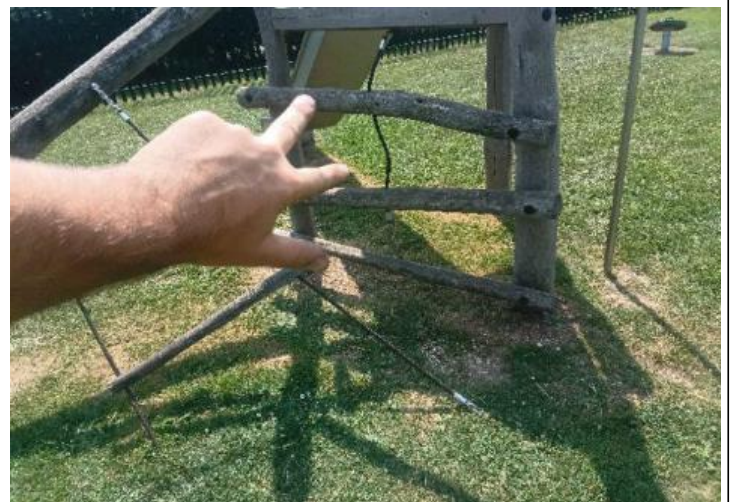
Item: Activity Equipment - Activity Platforms
Manufacturer: Kompan Ltd

A number of fixing(s) have worked loose - Secure all loose fixings

Finding: A number of fixing(s) have worked loose

Action: Secure all loose fixings

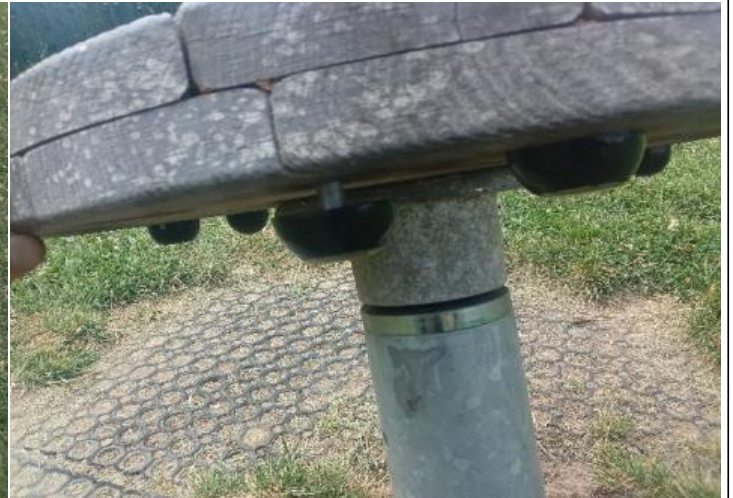
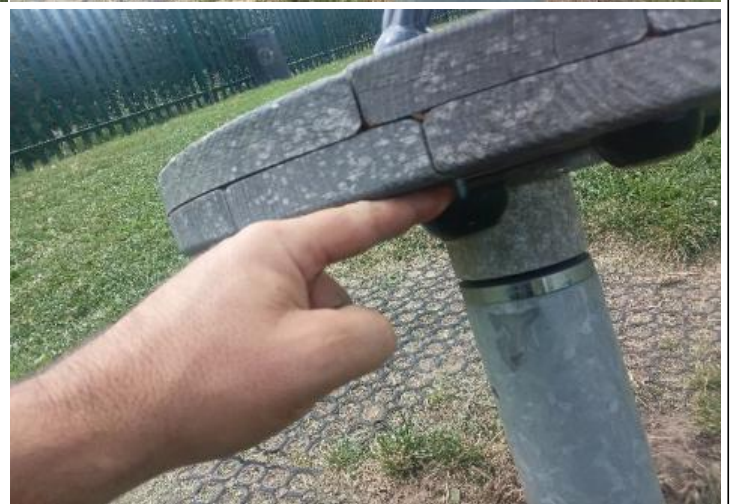
Item: Rotor Play - Spinner
Manufacturer: Kompan Ltd

A number of fixing(s) have worked loose - Secure all loose fixings

Finding: A number of fixing(s) have worked loose

Action: Secure all loose fixings

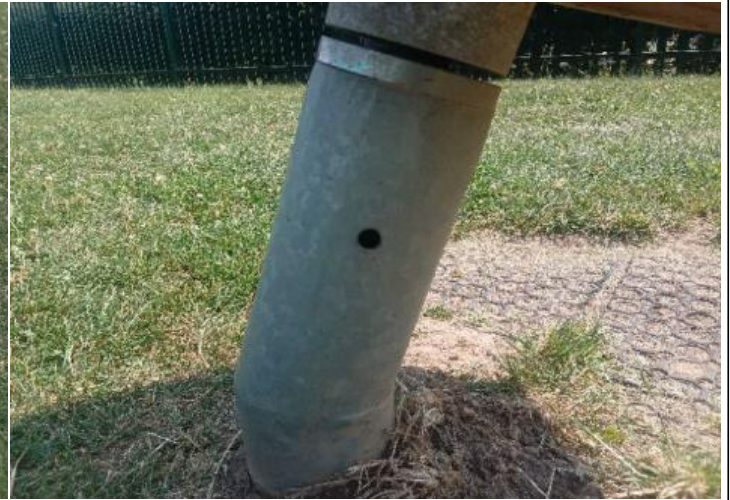
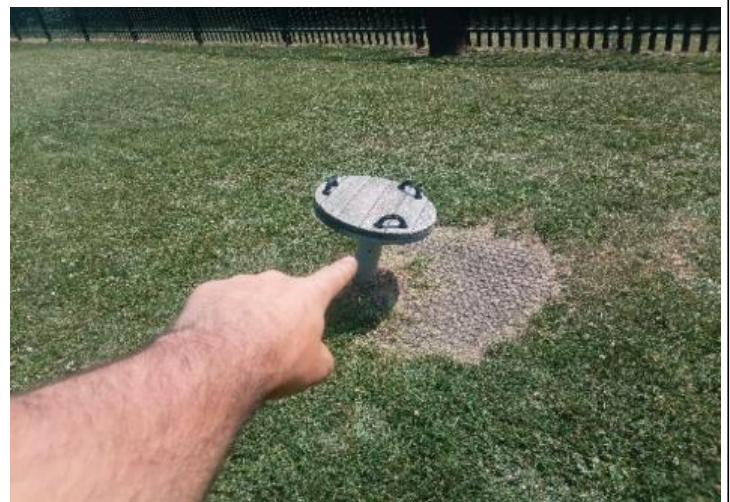
Item: Rotor Play - Spinner
Manufacturer: Kompan Ltd

There is/are inserts missing - Replace missing inserts

Finding: There is/are inserts missing

Action: Replace missing inserts

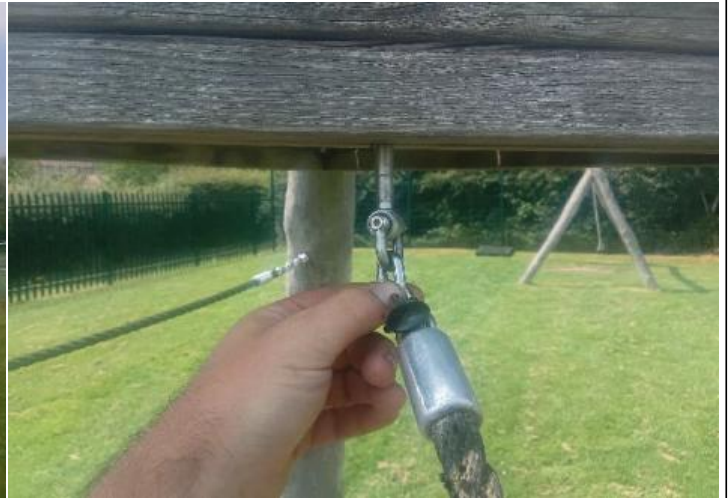
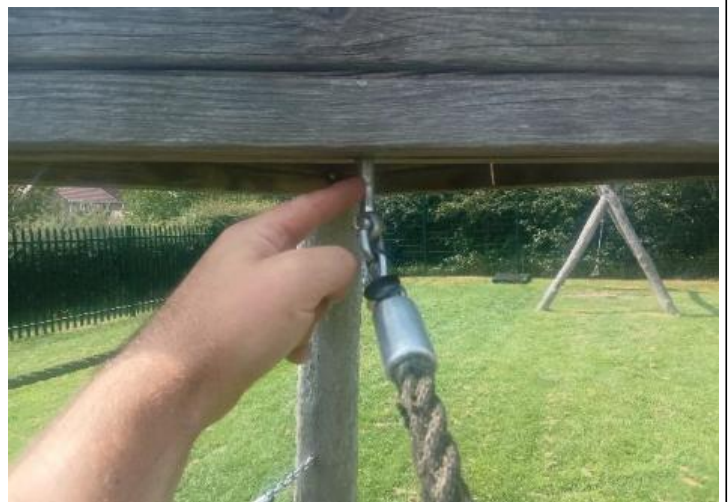
Item: Activity Equipment - Activity Platforms
Manufacturer: Kompan Ltd

A number of fixing(s) have worked loose - Secure all loose fixings

Finding: A number of fixing(s) have worked loose

Action: Secure all loose fixings

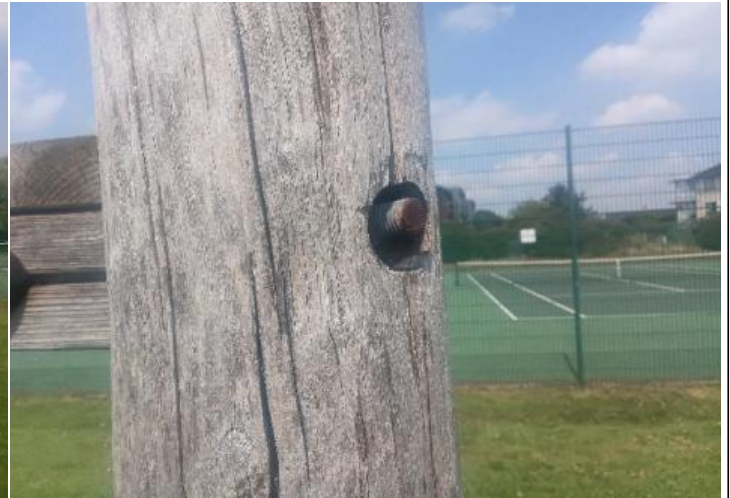
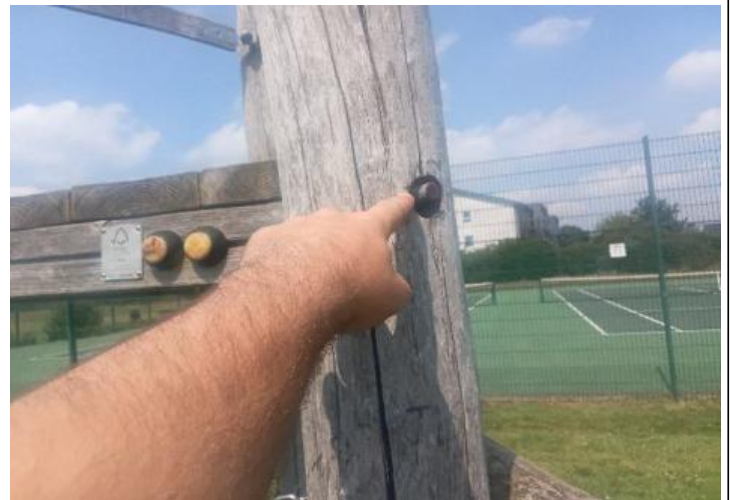
Item: Activity Equipment - Activity Platforms
Manufacturer: Kompan Ltd

There is/are bolt cap covers missing or damaged on the item - Replace missing or damaged bolt cap covers

Finding: There is/are bolt cap covers missing or damaged on the item

Action: Replace missing or damaged bolt cap covers

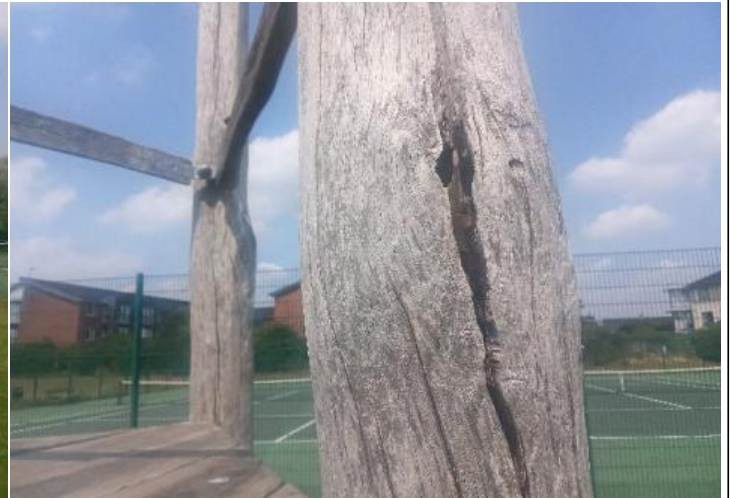
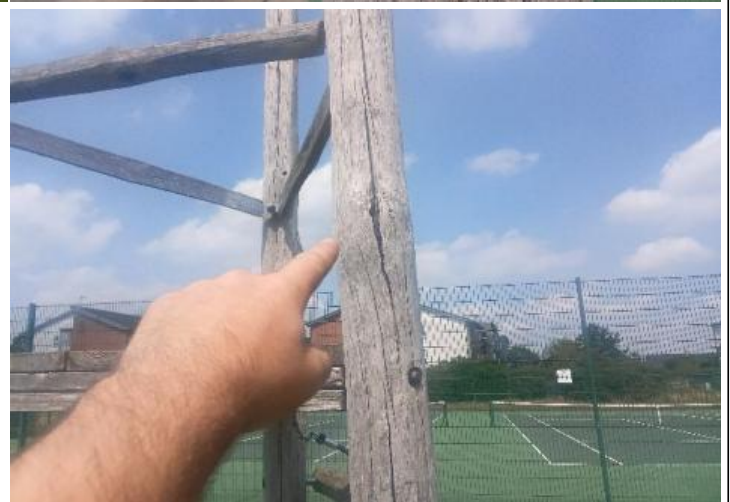
Item: Activity Equipment - Activity Platforms
Manufacturer: Kompan Ltd

There are splits running through the timber that cross through or near fixing points and may cause instability in the future - Monitor stability of fixings

Finding: There are splits running through the timber that cross through or near fixing points and may cause instability in the future

Action: Monitor stability of fixings

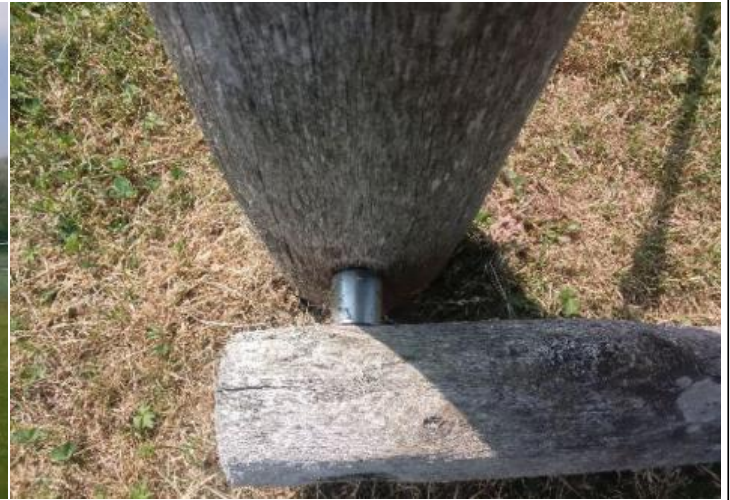
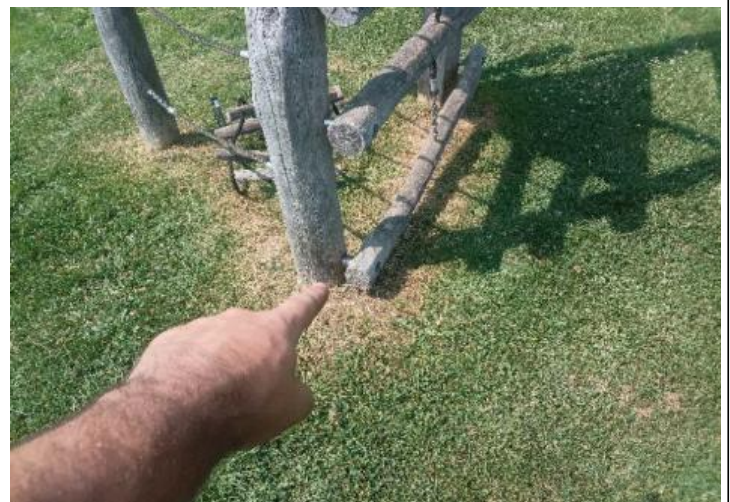
Item: Activity Equipment - Activity Platforms
Manufacturer: Kompan Ltd

A number of fixing(s) have worked loose - Secure all loose fixings

Finding: A number of fixing(s) have worked loose

Action: Secure all loose fixings

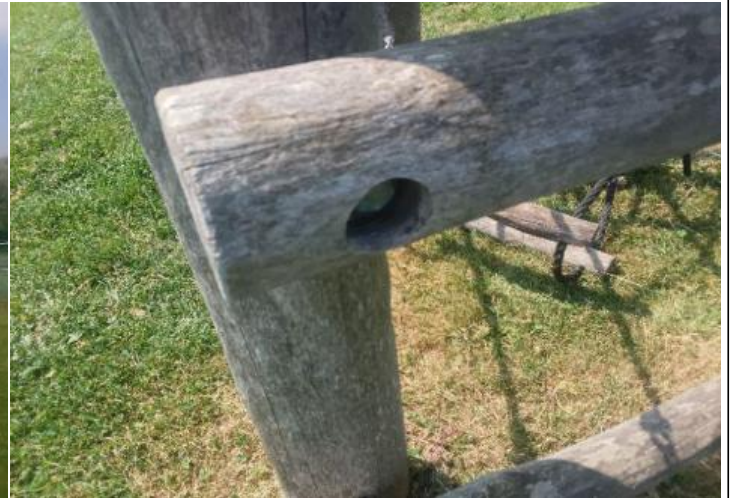
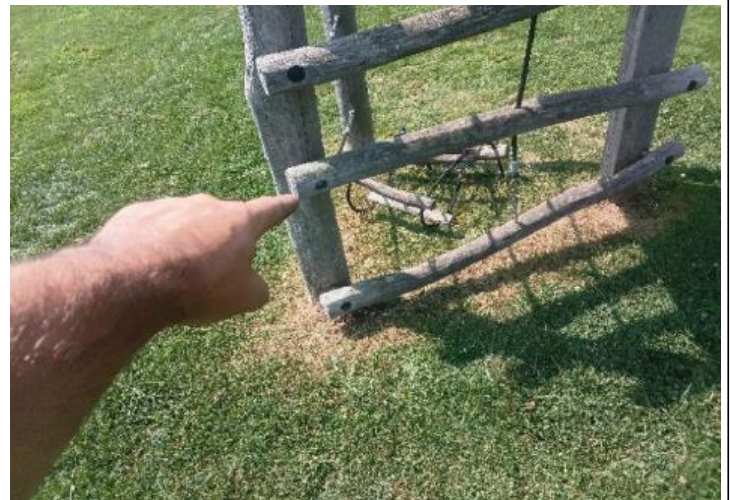
Item: Activity Equipment - Activity Platforms
Manufacturer: Kompan Ltd

There is/are bolt cap covers missing or damaged on the item - Replace missing or damaged bolt cap covers

Finding: There is/are bolt cap covers missing or damaged on the item

Action: Replace missing or damaged bolt cap covers

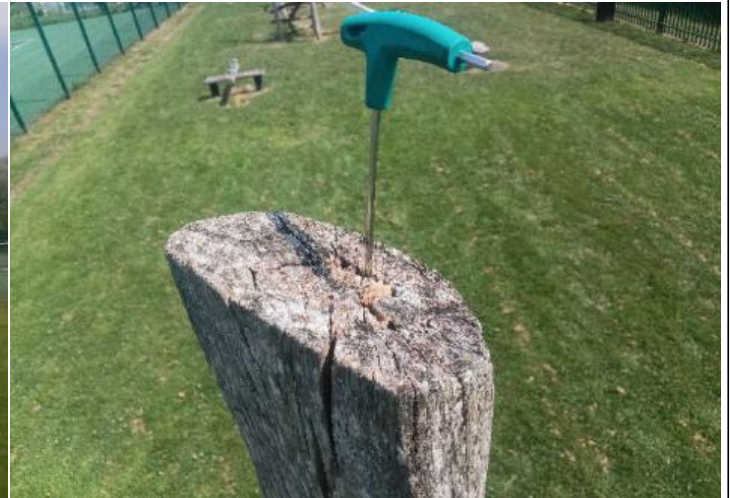
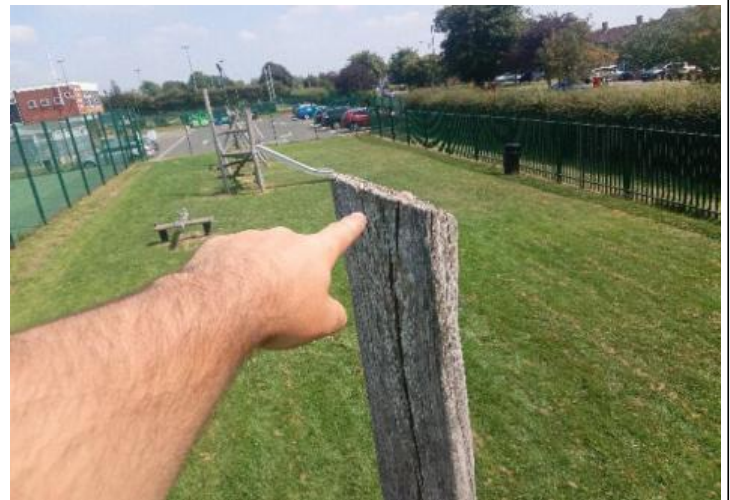
Item: Activity Equipment - Activity Platforms
Manufacturer: Kompan Ltd

There is some evidence of rot in the timber - Monitor for any further deterioration and replace as required

Finding: There is some evidence of rot in the timber

Action: Monitor for any further deterioration and replace as required

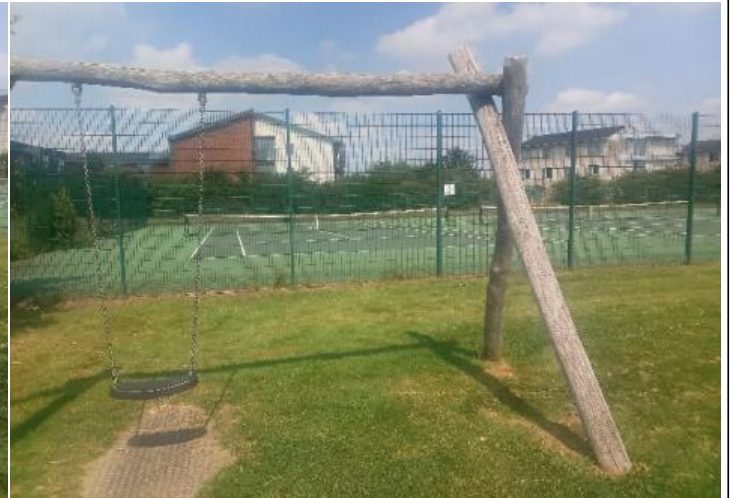
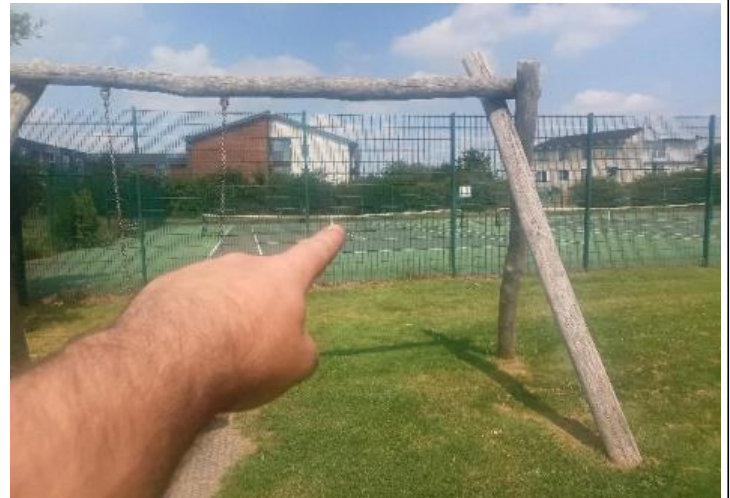
Item: Swings - 1 Bay 2 Seat (Flat)
Manufacturer: Kompan Ltd

The seat(s) and suspension were missing at the time of inspection and the inspector was unable to make a full compliance assessment - Replace missing seat(s) and suspension

Finding: The seat(s) and suspension were missing at the time of inspection and the inspector was unable to make a full compliance assessment

Action: Replace missing seat(s) and suspension

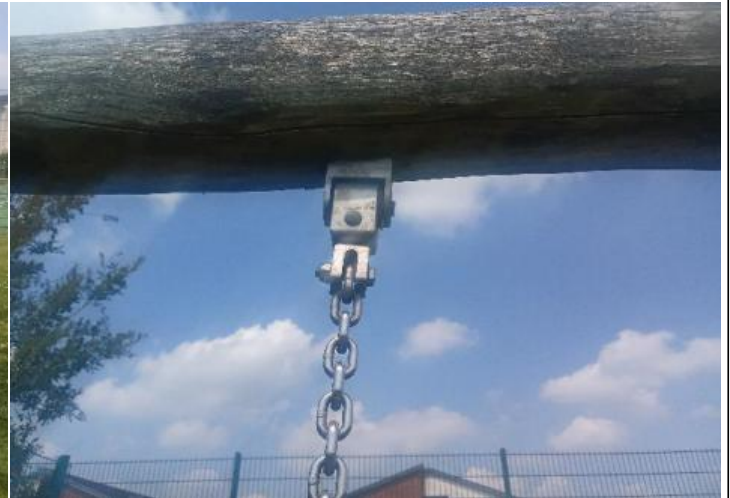
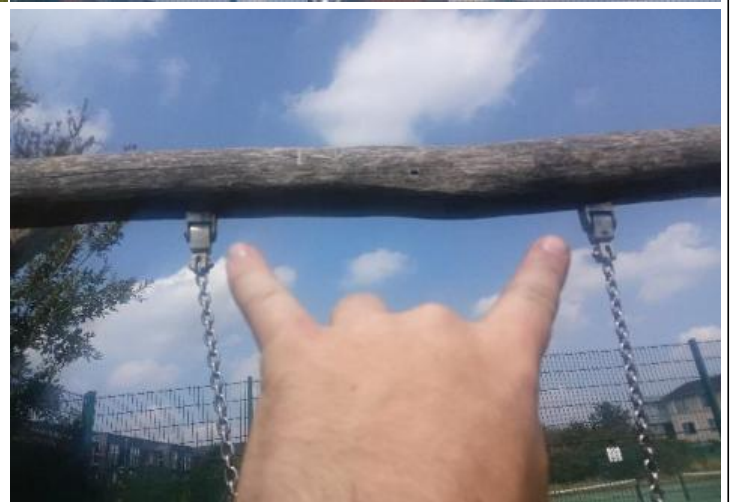
Item: Swings - 1 Bay 2 Seat (Flat)
Manufacturer: Kompan Ltd

A number of fixing(s) have worked loose - Secure all loose fixings

Finding: A number of fixing(s) have worked loose

Action: Secure all loose fixings

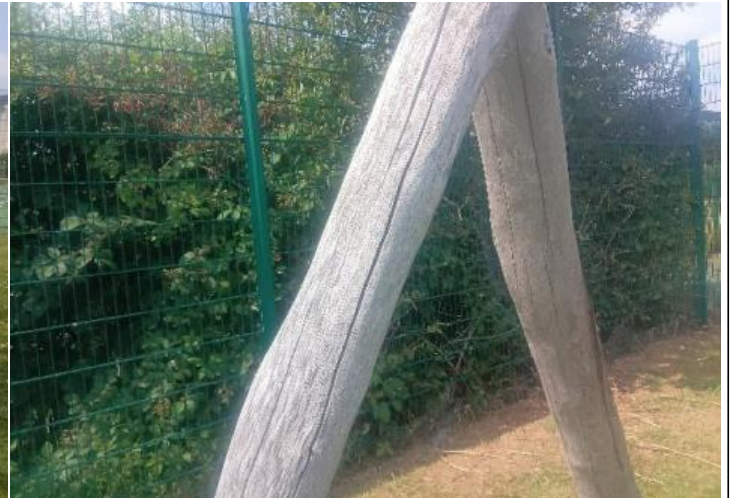
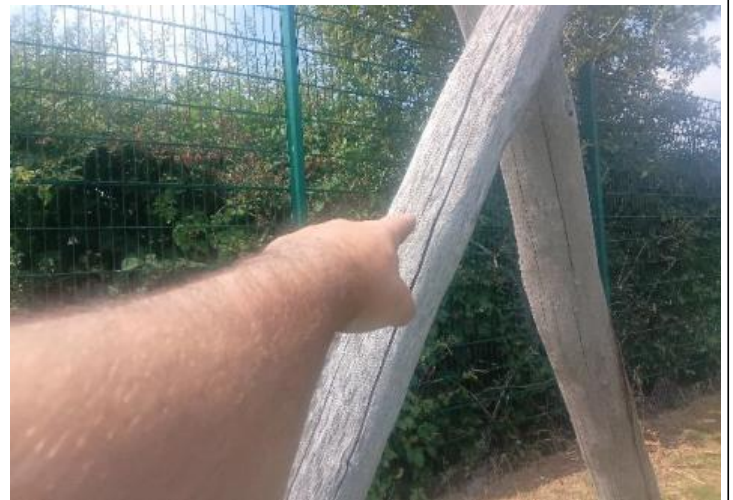
Item: Swings - 1 Bay 2 Seat (Flat)
Manufacturer: Kompan Ltd

The timber has a number of splits/shakes or air cracks and this may affect the stability or allow water ingress which will accelerate the rotting process - Monitor to ensure the splits do not cross through fixing points of the structure and/or cause any instability

Finding: The timber has a number of splits/shakes or air cracks and this may affect the stability or allow water ingress which will accelerate the rotting process
Action: Monitor to ensure the splits do not cross through fixing points of the structure and/or cause any instability

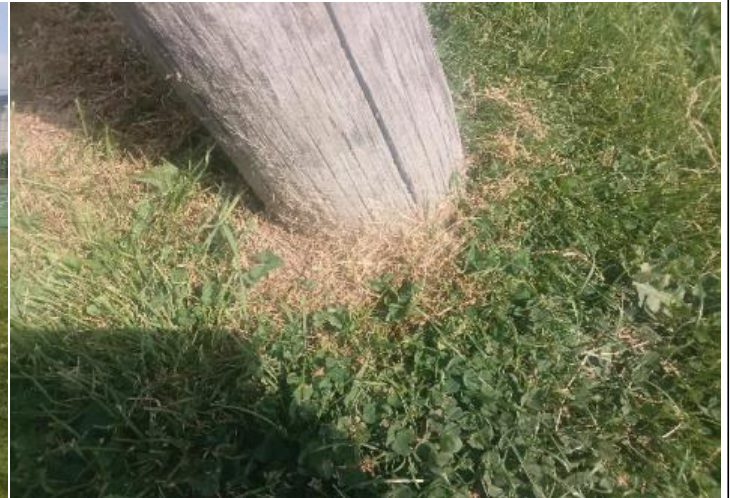
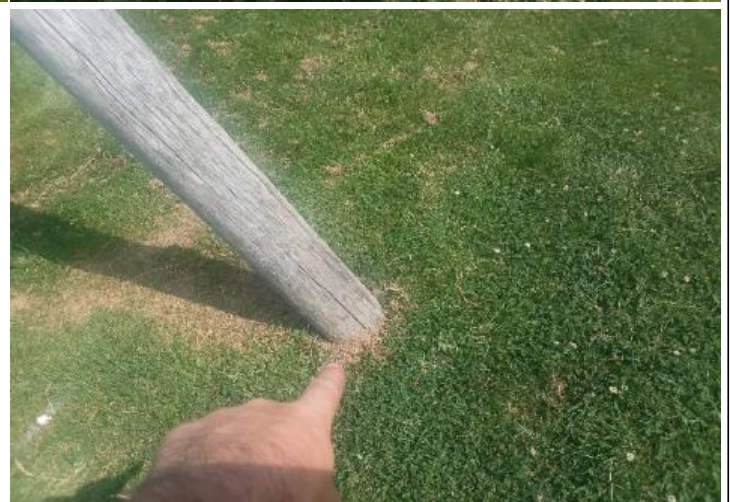
Item: Swings - 1 Bay 2 Seat (Flat)
Manufacturer: Kompan Ltd

There is some strimmer / machinery damage apparent on the posts, this can penetrate the preservative applied to the timber and accelerate the rotting process - Monitor for any deterioration (rot) and replace as required

Finding: There is some strimmer / machinery damage apparent on the posts, this can penetrate the preservative applied to the timber and accelerate the rotting process

Action: Monitor for any deterioration (rot) and replace as required

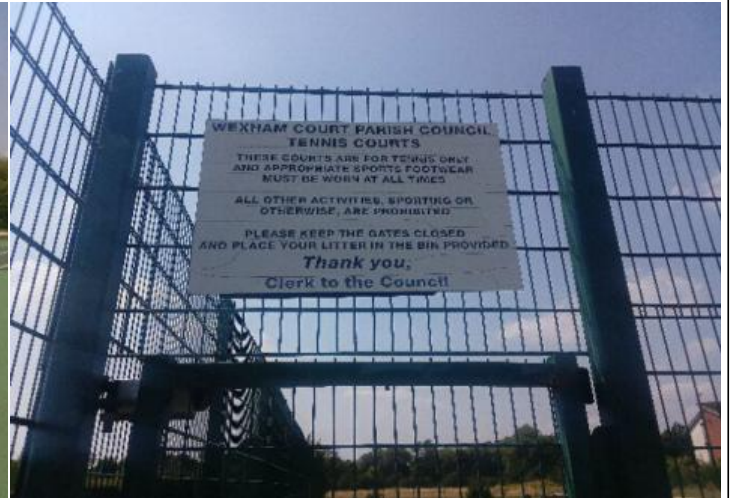
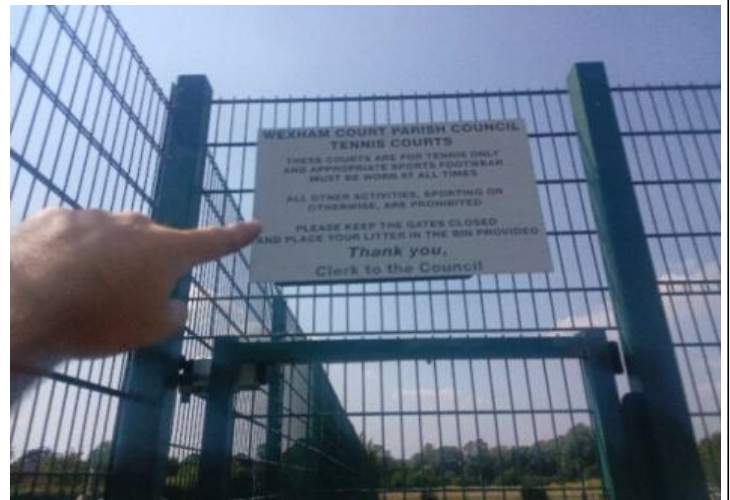
Item: Multi Use Games Area - Tennis Court
Manufacturer: Not Identified

A clearly visible facility sign should be provided in a prominent position with the wording as detailed BS EN 15312- the equipment is not intended for children less than 3 years old- the warning - Do not climb on the framework or nets- the warning - Do not hang on the ring (if provided)- the warning - Do not wear rings or other jewellery- name and telephone number of the administrator- number to call in case of accident - Provide signage to BS EN 15312

Finding: A clearly visible facility sign should be provided in a prominent position with the wording as detailed BS EN 15312- the equipment is not intended for children less than 3 years old- the warning - Do not climb on the framework or nets- the warning - Do not hang on the ring (if provided)- the warning - Do not wear rings or other jewellery- name and telephone number of the administrator- number to call in case of accident

Action: Provide signage to BS EN 15312

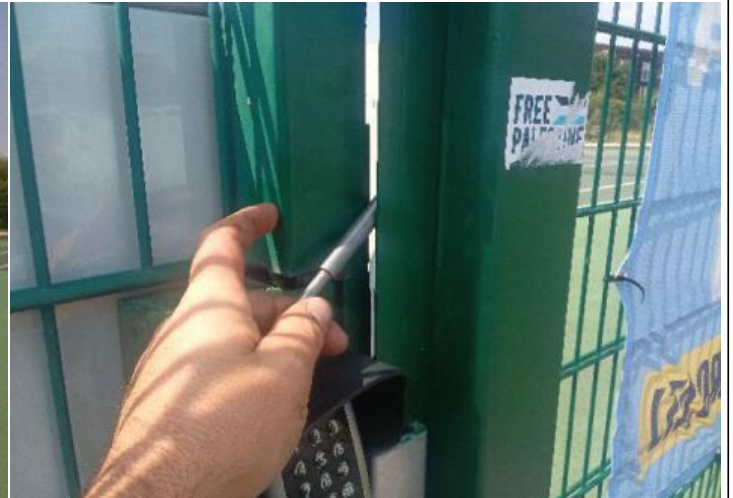
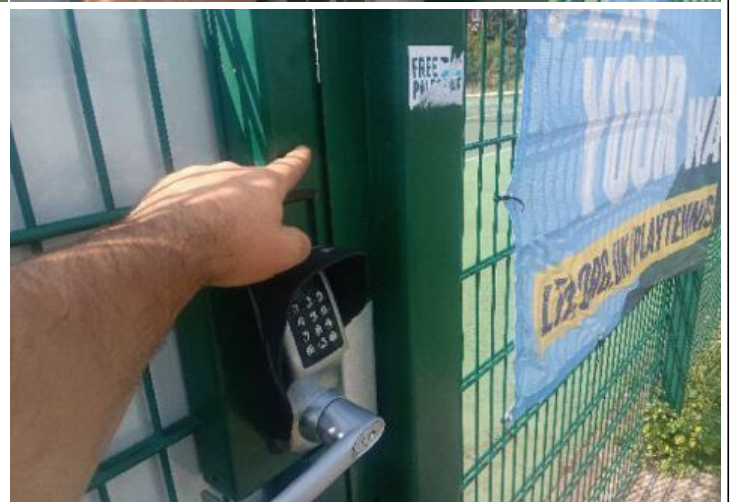
Item: Multi Use Games Area - Tennis Court
Manufacturer: Not Identified

BS EN 15312 states that gaps whose dimensions change during use shall have a minimum dimension of 18mm - Ensure crushing hazards are removed

Finding: BS EN 15312 states that gaps whose dimensions change during use shall have a minimum dimension of 18mm

Action: Ensure crushing hazards are removed

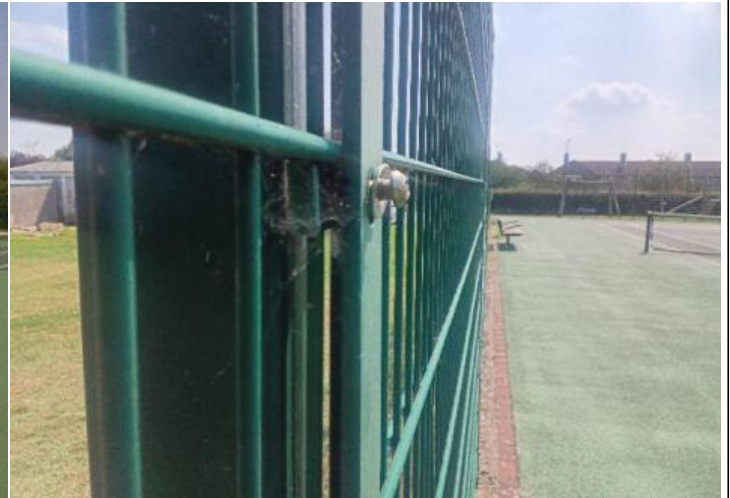
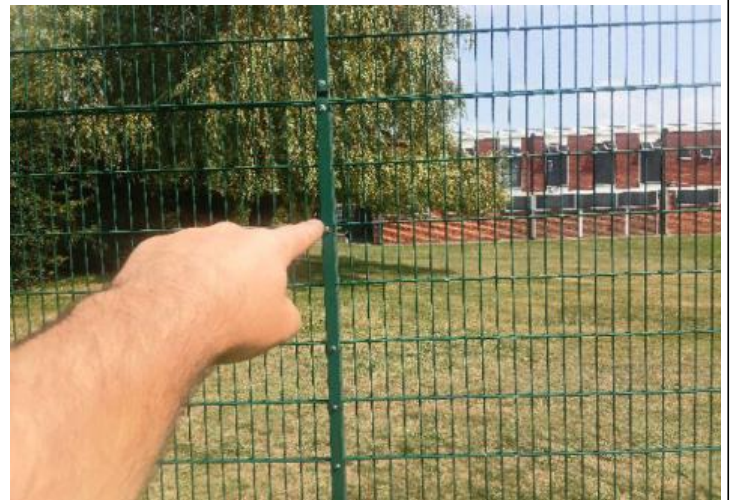
Item: Multi Use Games Area - Tennis Court
Manufacturer: Not Identified

A number of fixing(s) have worked loose - Secure all loose fixings

Finding: A number of fixing(s) have worked loose

Action: Secure all loose fixings
