the **play inspection** company

Annual Inspection

Wexham Court Parish Council

Norway Drive Recreation Ground

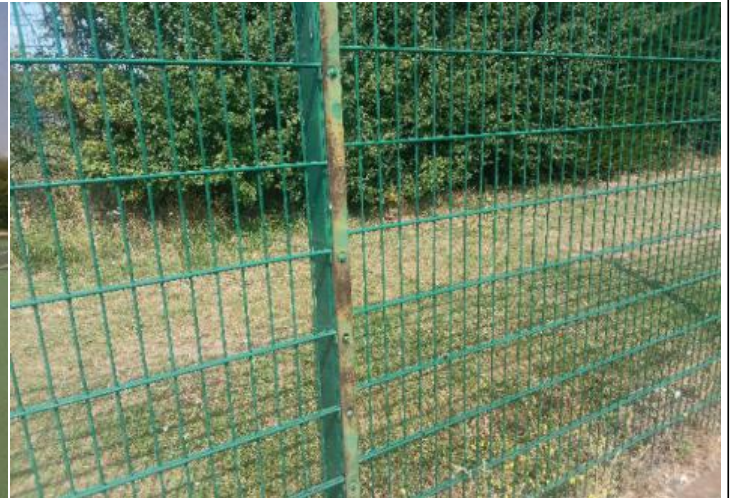
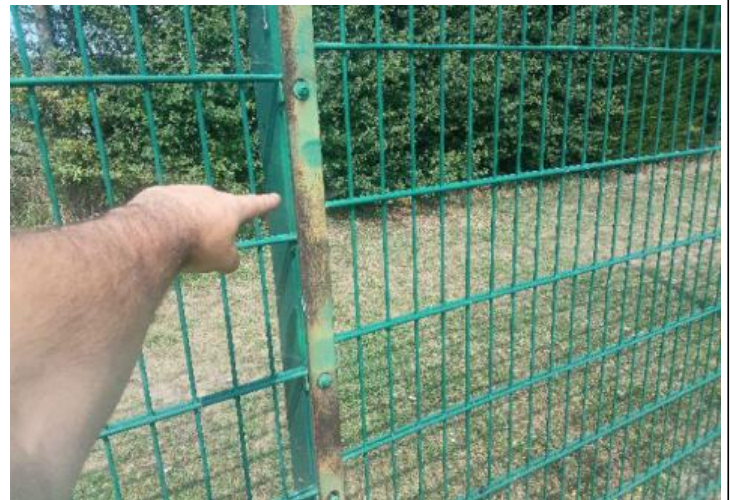
Item: Multi Use Games Area - Tennis Court
Manufacturer: Not Identified

The paintwork on this item has been damaged or worn exposing the metal underneath which is rusting / corroding - Treat affected areas and repaint

Finding: The paintwork on this item has been damaged or worn exposing the metal underneath which is rusting / corroding

Action: Treat affected areas and repaint

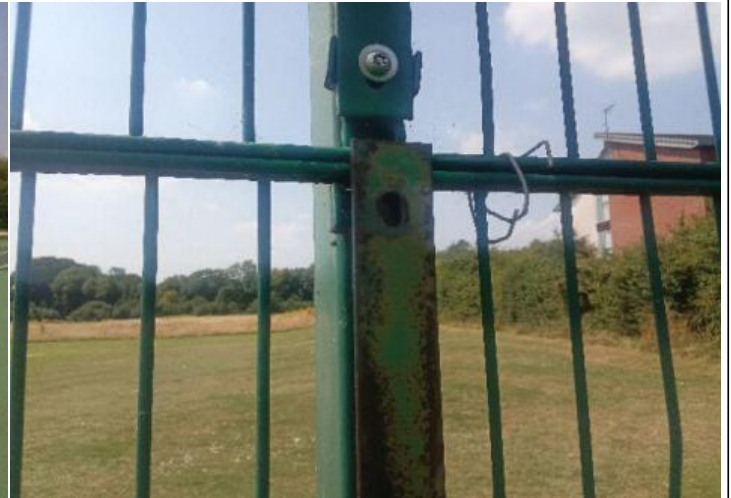
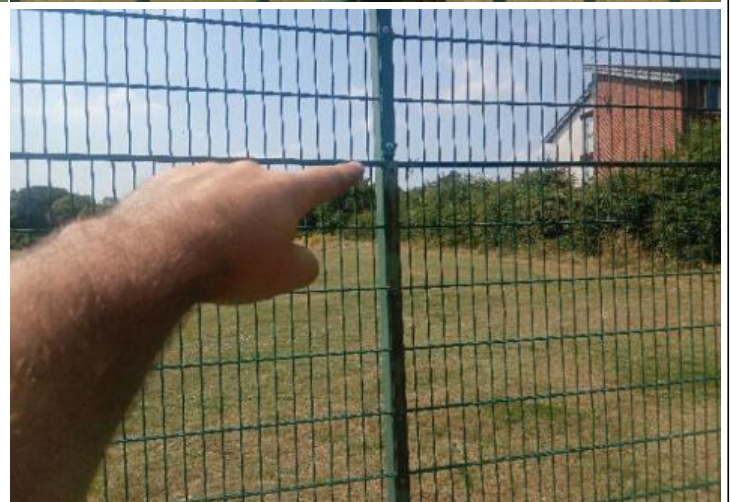
Item: Multi Use Games Area - Tennis Court
Manufacturer: Not Identified

There is or are fixings missing on the item - Replace all missing fixings

Finding: There is or are fixings missing on the item

Action: Replace all missing fixings

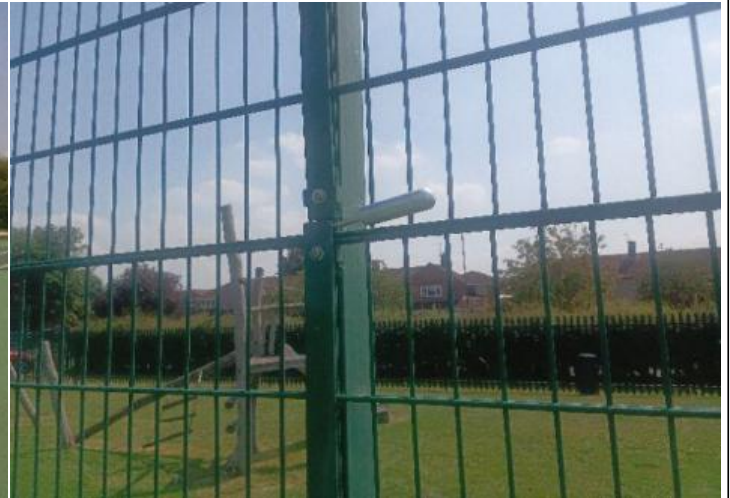
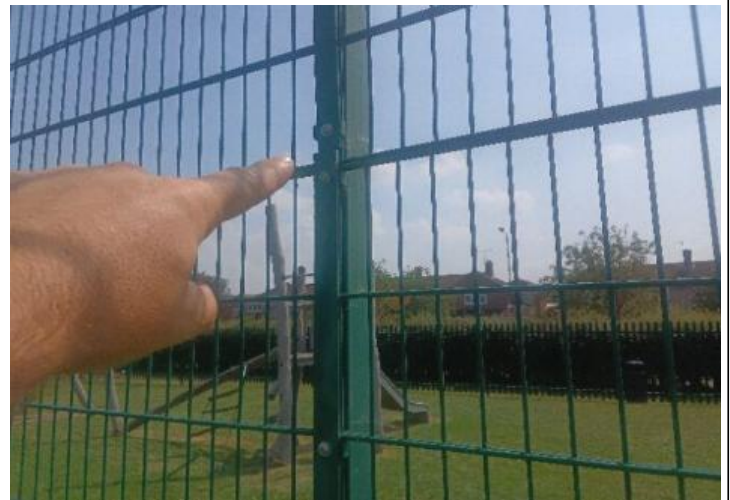
Item: Multi Use Games Area - Tennis Court
Manufacturer: Not Identified

There is/are finger entrapments in the panelling and the item fails to meet the requirements of BS EN 15312 Clause 4.4.2.2 Entrapment of fingers - Monitor - No remedial work recommended

Finding: There is/are finger entrapments in the panelling and the item fails to meet the requirements of BS EN 15312 Clause 4.4.2.2 Entrapment of fingers

Action: Monitor - No remedial work recommended

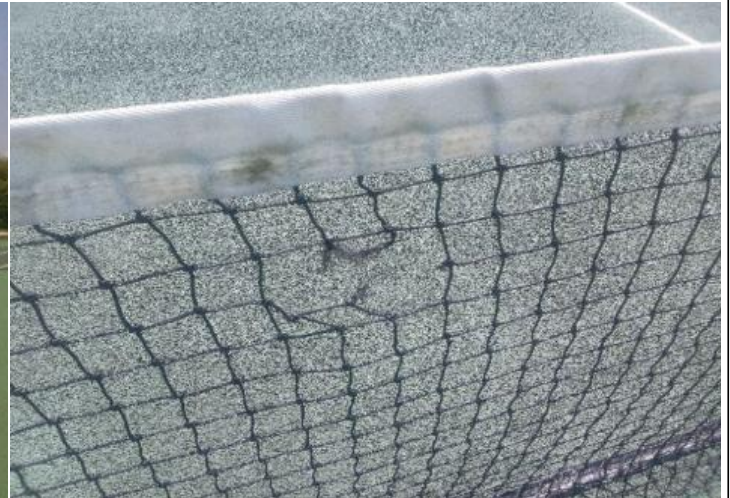
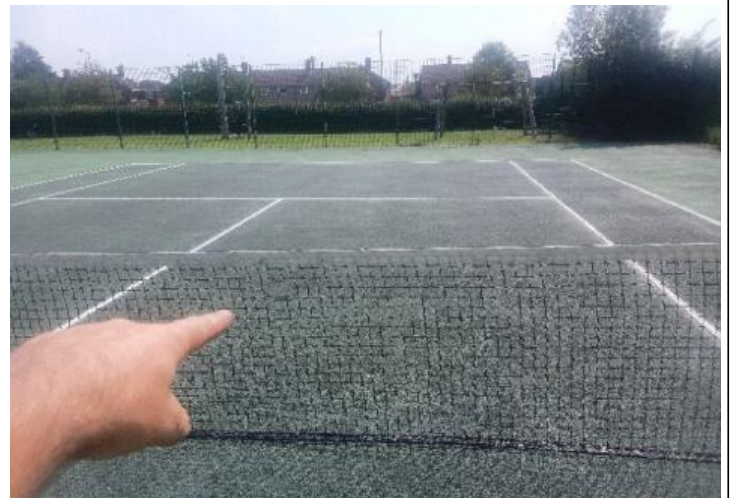
Item: Multi Use Games Area - Tennis Court
Manufacturer: Not Identified

The net has some minor damage - Monitor for any further deterioration and replace as required

Finding: The net has some minor damage

Action: Monitor for any further deterioration and replace as required

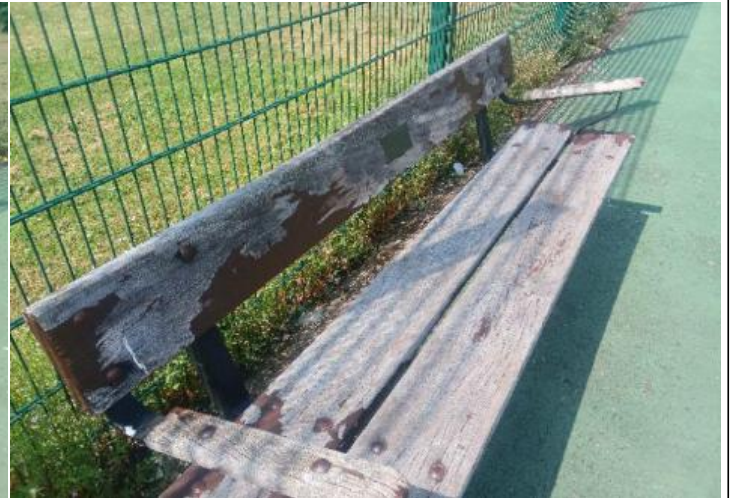
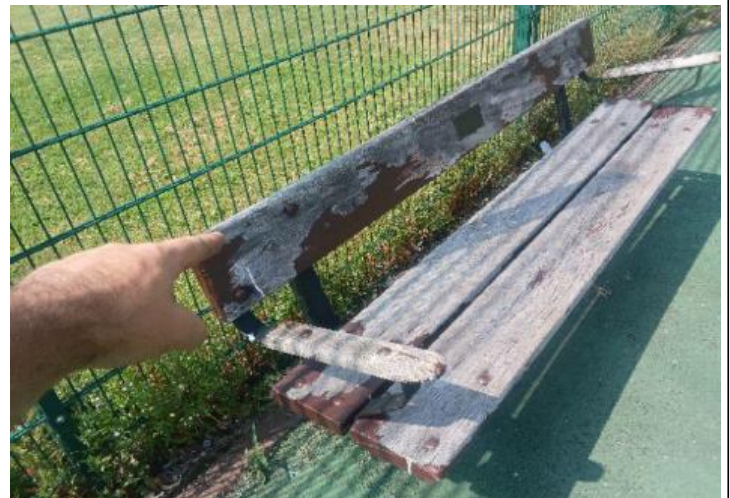
Item: Ancillary Items - Bench
Manufacturer: Not Identified

The timber stain is in poor condition - Prepare all affected parts and re-stain with an appropriate preservative

Finding: The timber stain is in poor condition

Action: Prepare all affected parts and re-stain with an appropriate preservative

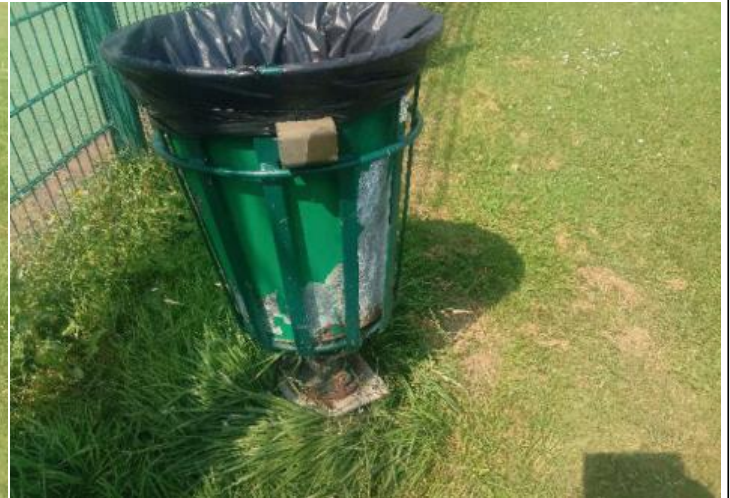
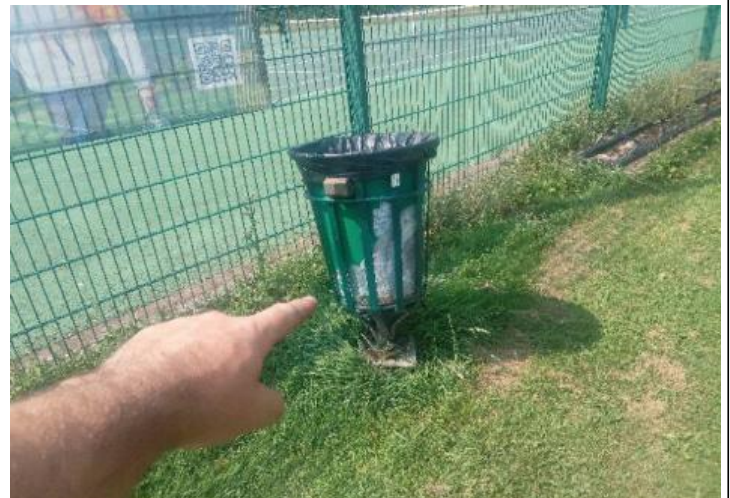
Item: Ancillary Items - Litter Bin
Manufacturer: Not Identified

The paintwork on this item has been damaged or worn exposing the metal underneath which is rusting / corroding - Treat affected areas and repaint

Finding: The paintwork on this item has been damaged or worn exposing the metal underneath which is rusting / corroding

Action: Treat affected areas and repaint
