the **play inspection** company

Annual Inspection

Wexham Court Parish Council

Norway Drive Recreation Ground

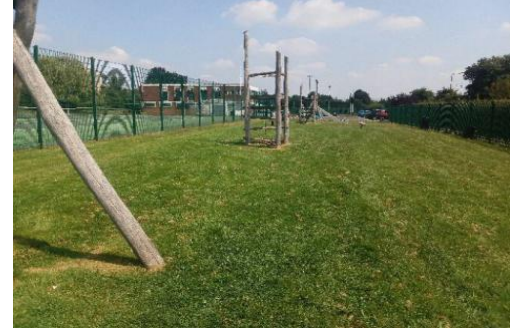
Unauthorised general waste has been left on site - Arrange removal of waste from site

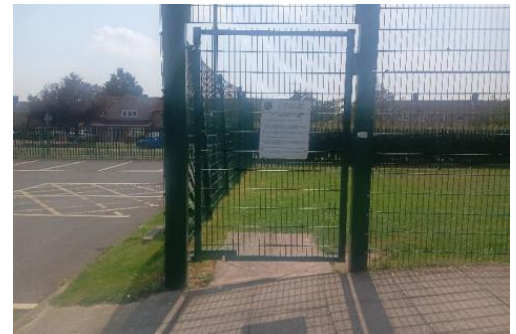
The area under the gate has eroded leaving uneven areas, or the concrete foundations exposed, resulting in trip hazards at the entrance/exit to the playground - Reinstate to level with surrounding surfaces

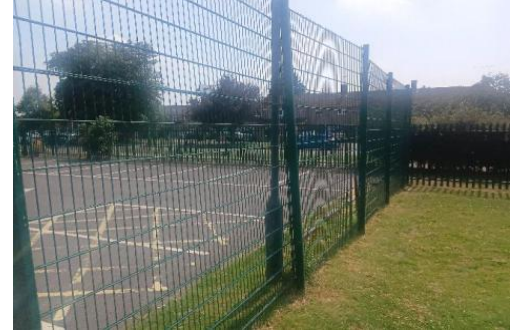
The surface has eroded and the foundations are exposed - Reinstate surrounding surfaces to cover the foundations

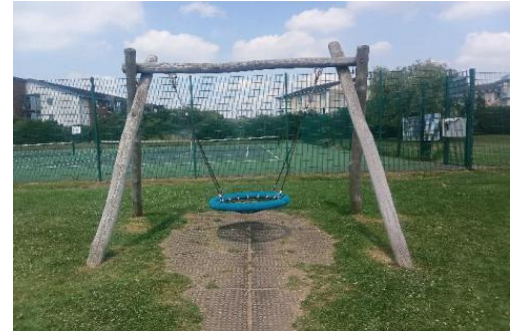
The grass mats are silted up and the soil is compacted; this may have an effect on the impact absorbing properties of the surface. Consideration should be given to HIC testing the surface to verify impact attenuating properties (<https://playinspections.co.uk/inspection-services/safety-surface-testing/>) - Contact our office for a quotation for this service

There is some strimmer / machinery damage apparent on the posts, this can penetrate the preservative applied to the timber and accelerate the rotting process - Monitor for any deterioration (rot) and replace as required

The bushes are showing signs of wear - Monitor for any further deterioration and replace as required

There is some evidence of fire damage to the item - Monitor for any further deterioration and repair as required

The ropes on this item have been taped and we are unable to fully assess the condition of the rope, ensure no wire strands are broken beneath the tape - Repair or replace as required

The connecting links are in excess of 8.6mm and less than 12mm and fail the requirements of BS EN 1176 Part 1; clause 4.2.13, Chains - Monitor - No remedial work recommended

A number of fixing(s) have worked loose - Secure all loose fixings

The swivel joint fixings are very loose - Retighten fixings

There is some notable evidence of chain wear - Monitor for any further deterioration and replace when 40% worn

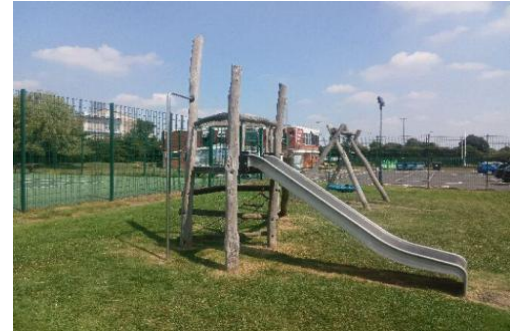
There are a number of dents in the slide surface - Monitor for any further deterioration and repair as required

The ropes/nets are worn/damaged in places - Monitor for any further deterioration and repair or replace as required

A number of fixing(s) have worked loose - Secure all loose fixings

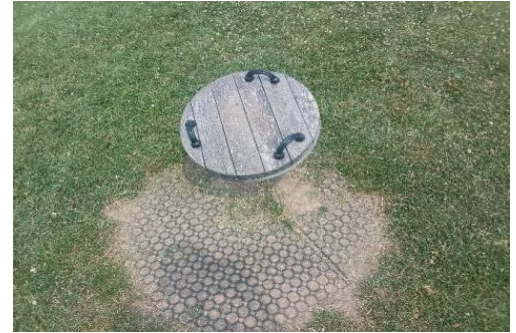
A number of fixing(s) have worked loose - Secure all loose fixings

There is/are inserts missing - Replace missing inserts

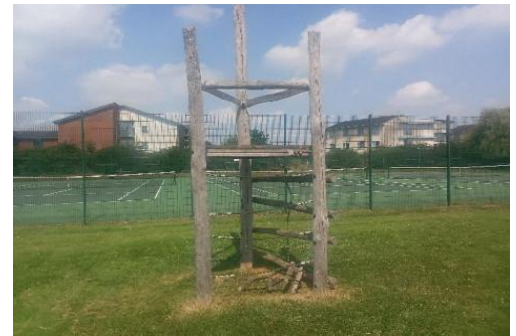
A number of fixing(s) have worked loose - Secure all loose fixings

There is/are bolt cap covers missing or damaged on the item - Replace missing or damaged bolt cap covers

There are splits running through the timber that cross through or near fixing points and may cause instability in the future - Monitor stability of fixings

There is some evidence of rot in the timber - Monitor for any further deterioration and replace as required

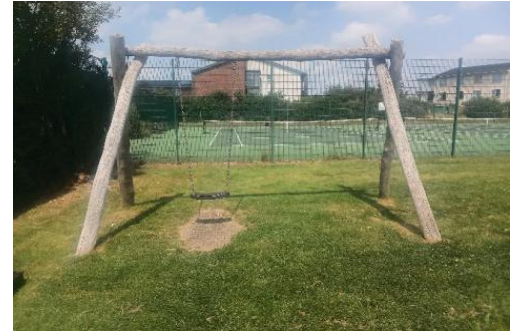
The seat(s) and suspension were missing at the time of inspection and the inspector was unable to make a full compliance assessment - Replace missing seat(s) and suspension

A number of fixing(s) have worked loose - Secure all loose fixings

The timber has a number of splits/shakes or air cracks and this may affect the stability or allow water ingress which will accelerate the rotting process - Monitor to ensure the splits do not cross through fixing points of the structure and/or cause any instability

There is some strimmer / machinery damage apparent on the posts, this can penetrate the preservative applied to the timber and accelerate the rotting process - Monitor for any deterioration (rot) and replace as required

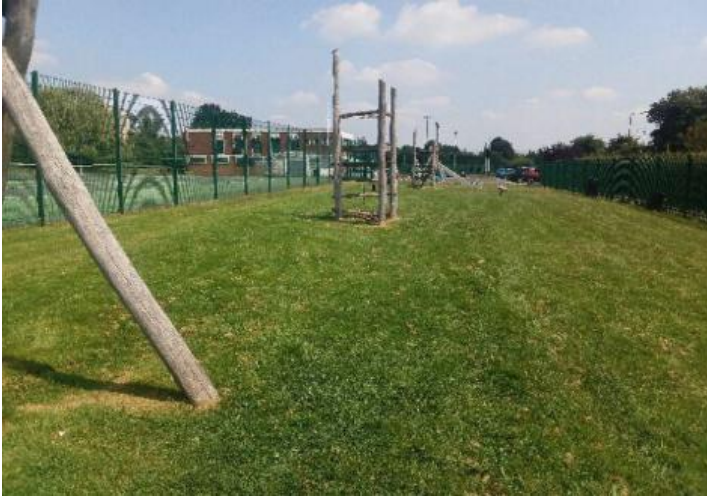
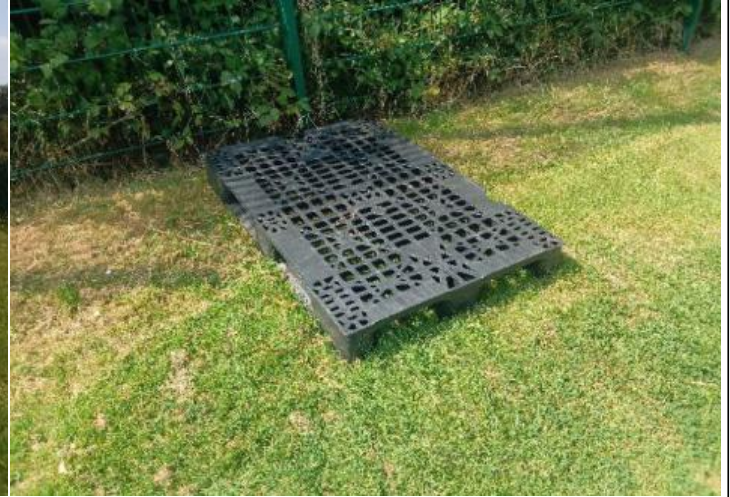
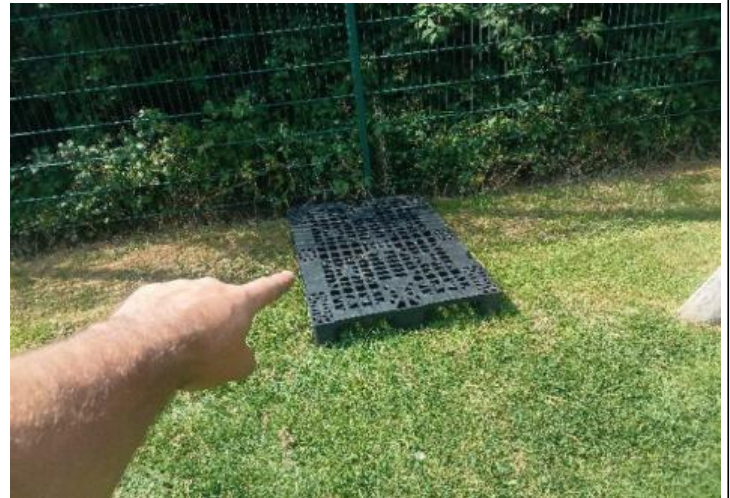
Finding: Unauthorised general waste has been left on site **Action:** Arrange removal of waste from site

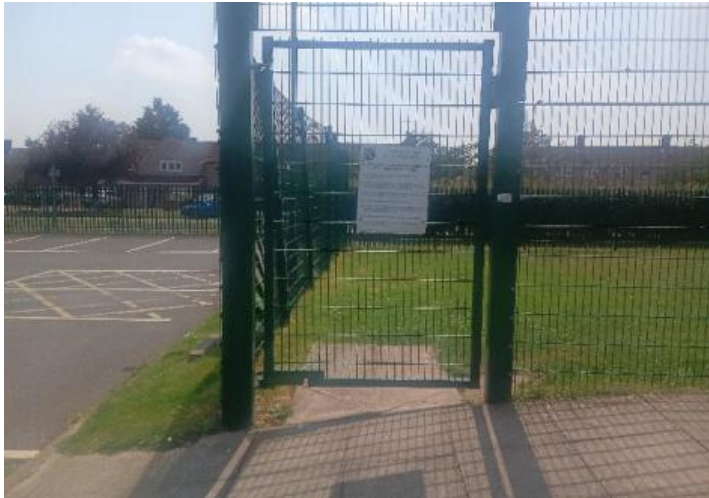
Finding: The area under the gate has eroded leaving uneven areas, or the concrete foundations exposed, resulting in trip hazards at the entrance/exit to the playground

Action: Reinststate to level with surrounding surfaces

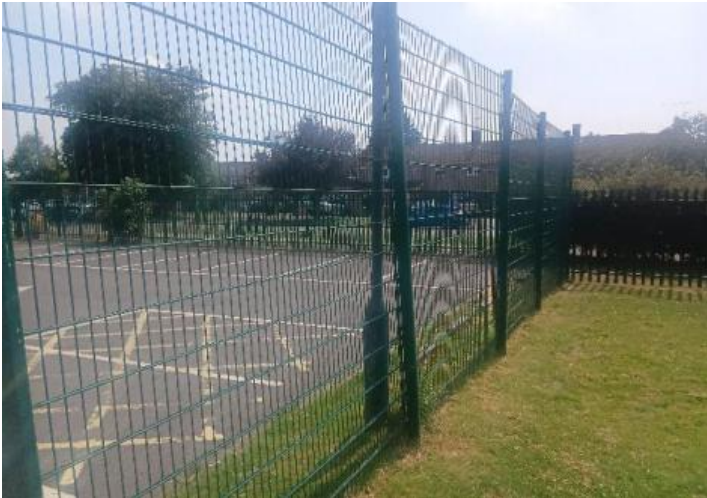
Finding: The surface has eroded and the foundations are exposed

Action: Reinststate surrounding surfaces to cover the foundations

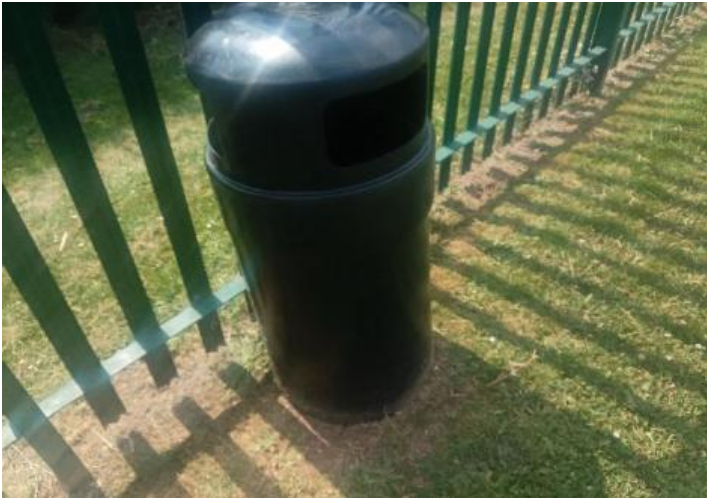
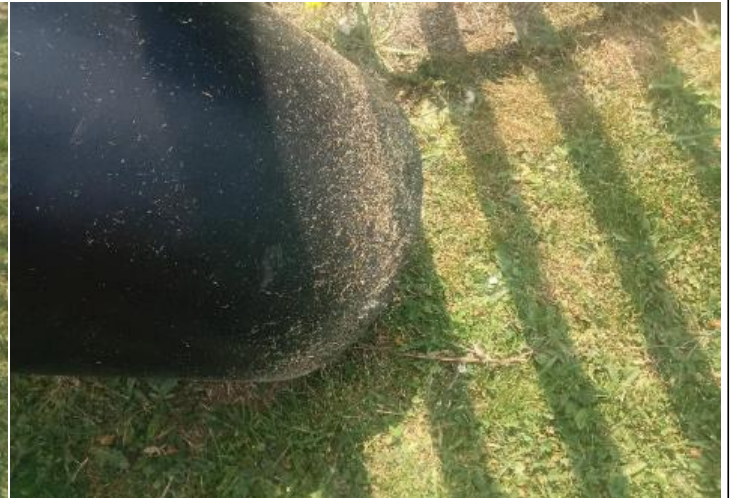
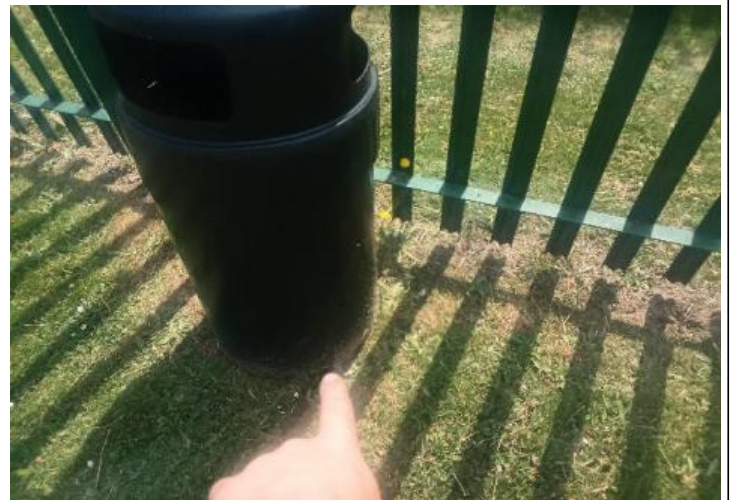
Finding: The bin is not securely fixed to the surface and there is some possibility of the item tipping or rolling over

Action: Secure the bin to the ground

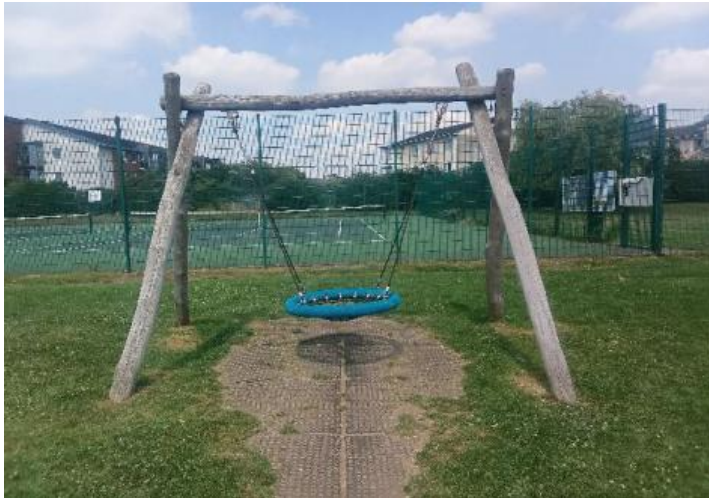
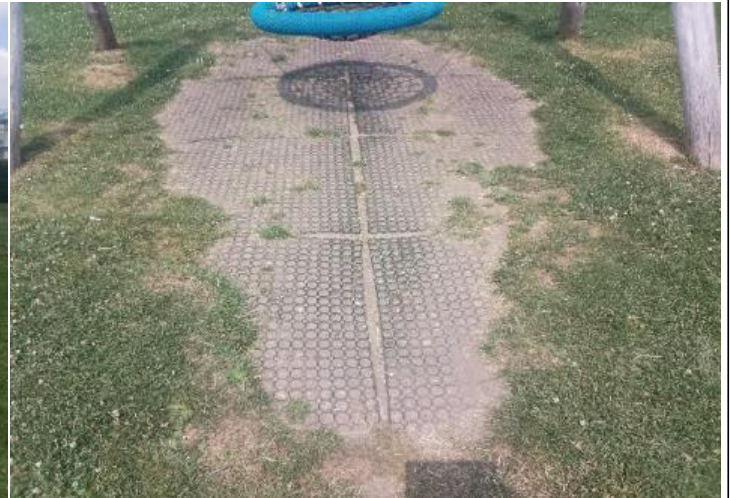
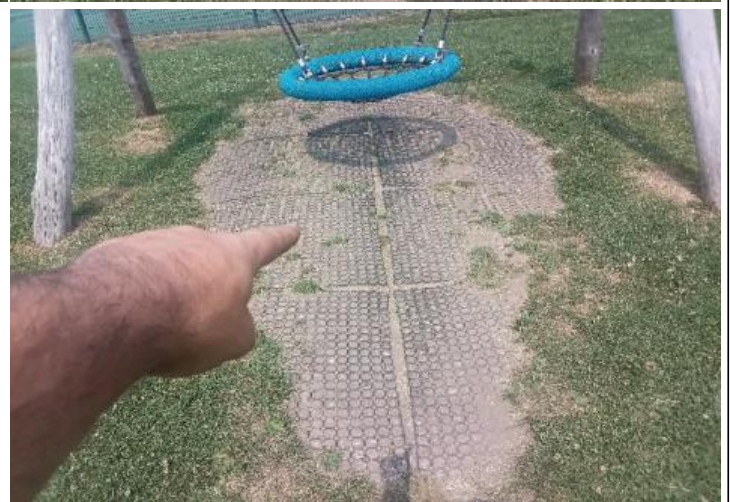
Finding: The grass mats are silted up and the soil is compacted; this may have an effect on the impact absorbing properties of the surface. Consideration should be given to HIC testing the surface to verify impact attenuating properties (<https://playinspections.co.uk/inspection-services/safety-surface-testing/>)

Action: Contact our office for a quotation for this service

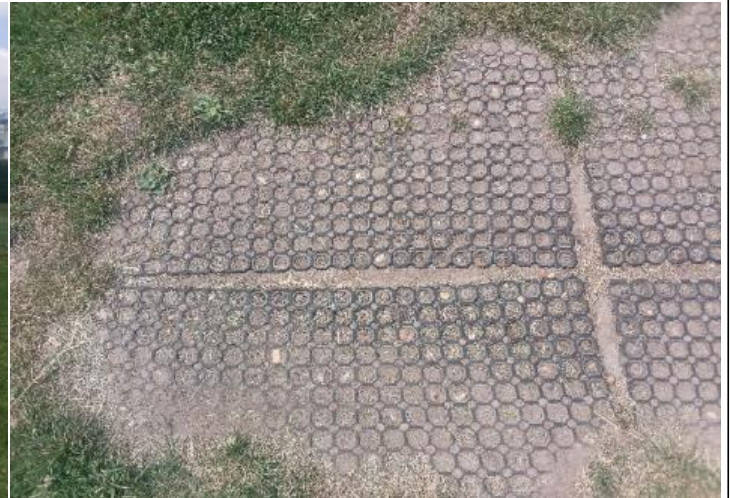
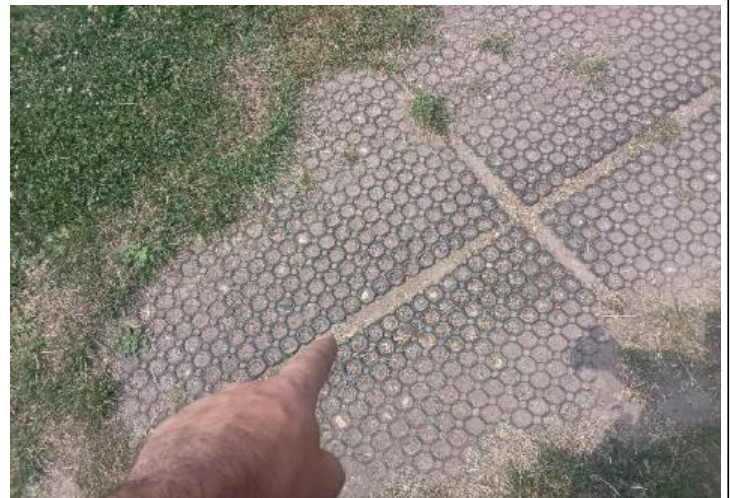
Finding: There are gaps opening between the grass mat tiles

Action: Provide additional ties or secure / reinstate surface

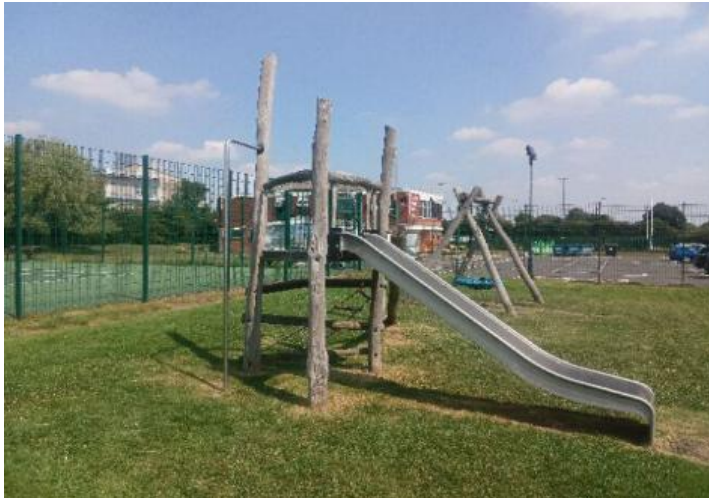
Finding: There are a number of dents in the slide surface

Action: Monitor for any further deterioration and repair as required

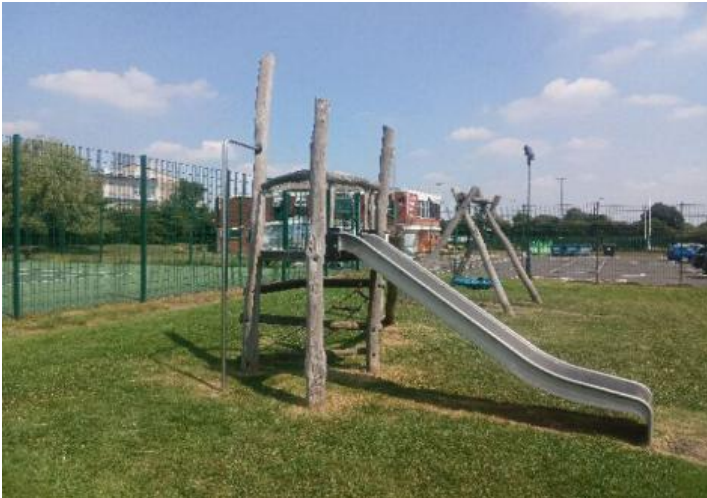
Finding: The ropes/nets are worn/damaged in places

Action: Monitor for any further deterioration and repair or replace as required

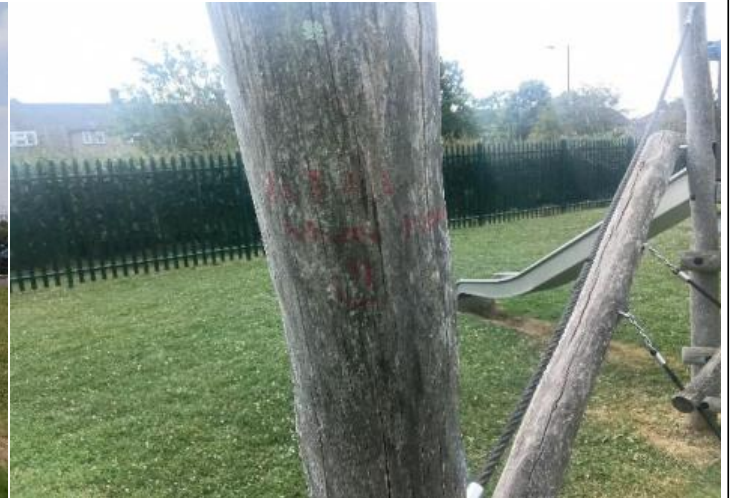
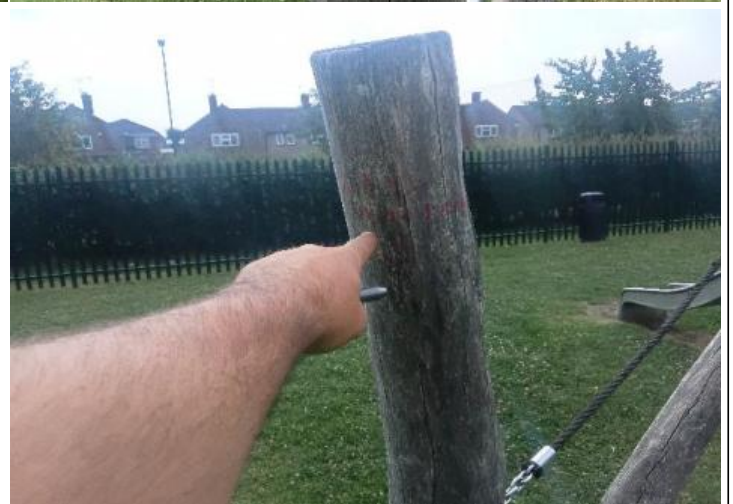
Finding: There is some graffiti present

Action: Remove the graffiti

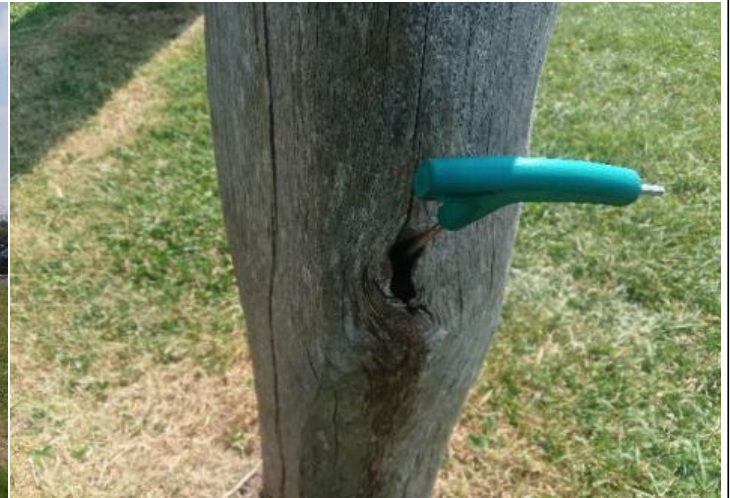
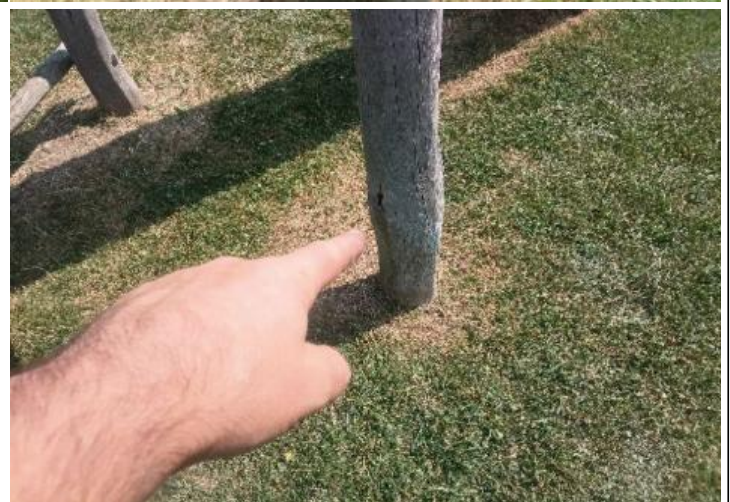
Finding: There are very large cavities within the posts

Action: Refer to manufacturer

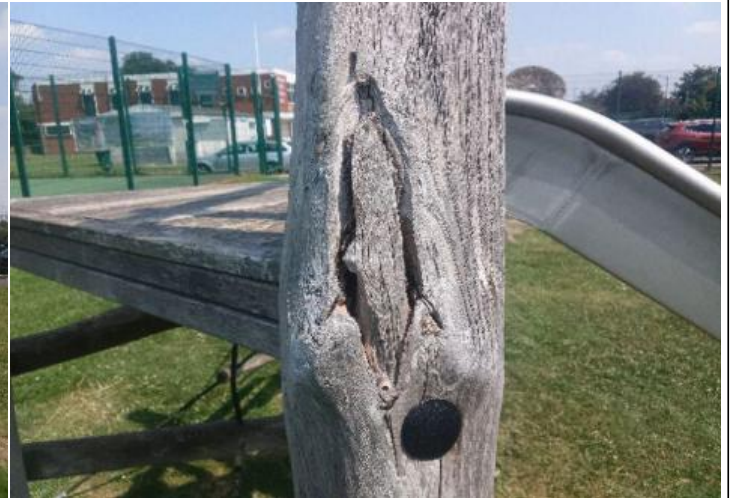
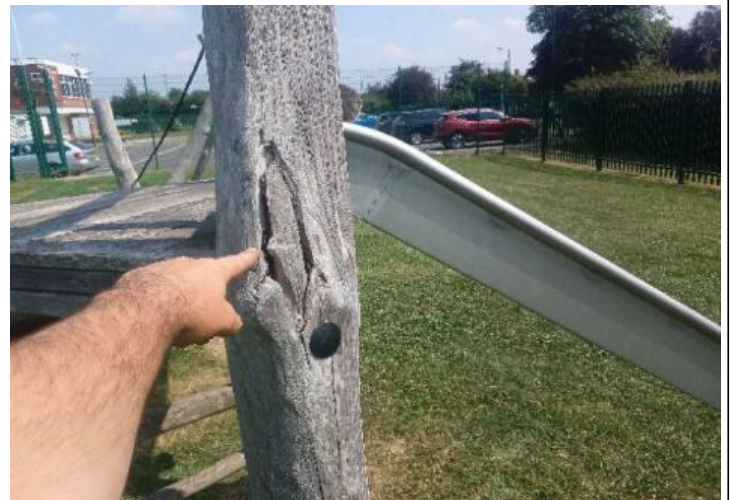
Finding: Parts of the timber are rough or splintered

Action: Remove all rough or sharp edges

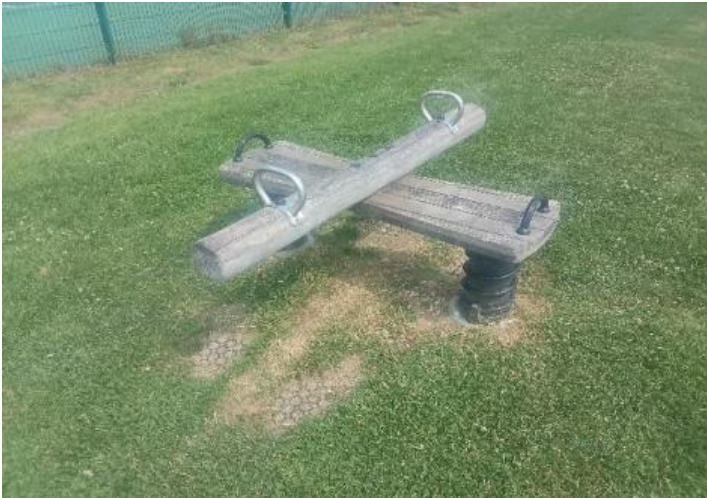
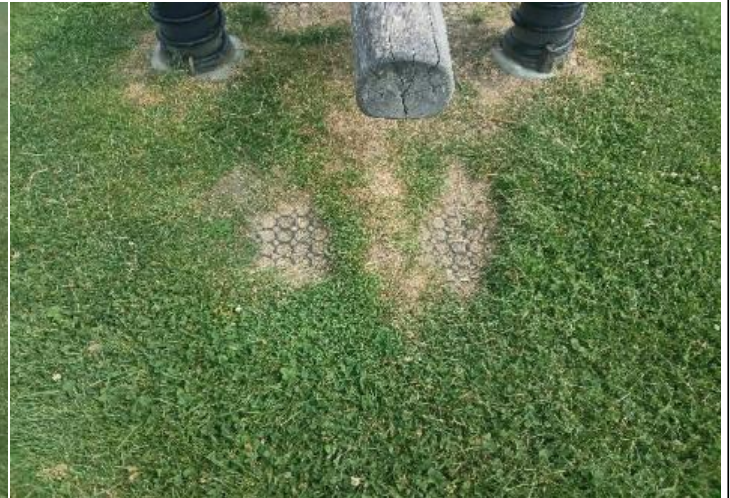
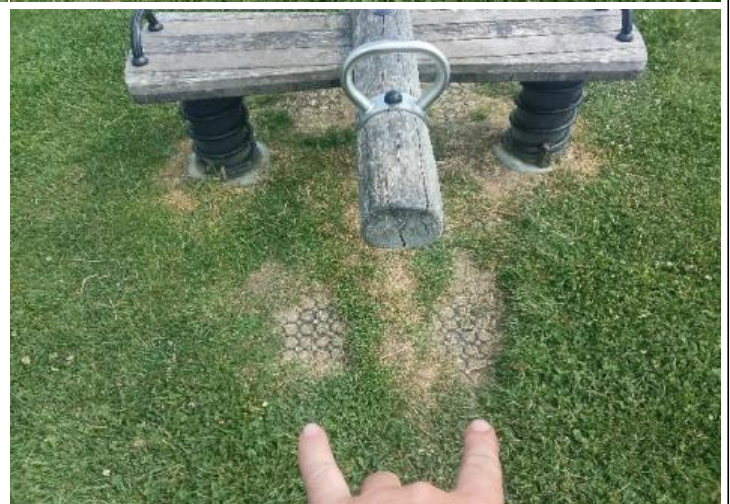
Item: Rocking Equipment - Four Way Springer
Manufacturer: Kompan Ltd

Risk Level: L - Low Risk
Surface: Grass Matrix Tiles

Finding: The grass mats are silted up, the soil is compacted and the area will become very slippery when the soil is wet. **Action:** Reinstate as required

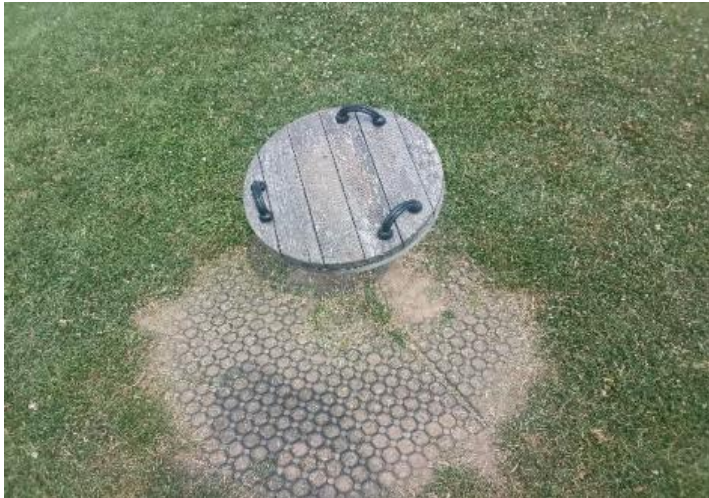
Item: Rotor Play - Spinner
Manufacturer: Kompan Ltd

Risk Level: L - Low Risk
Surface: Grass Matrix Tiles

Finding: A number of fixing(s) have worked loose

Action: Secure all loose fixings

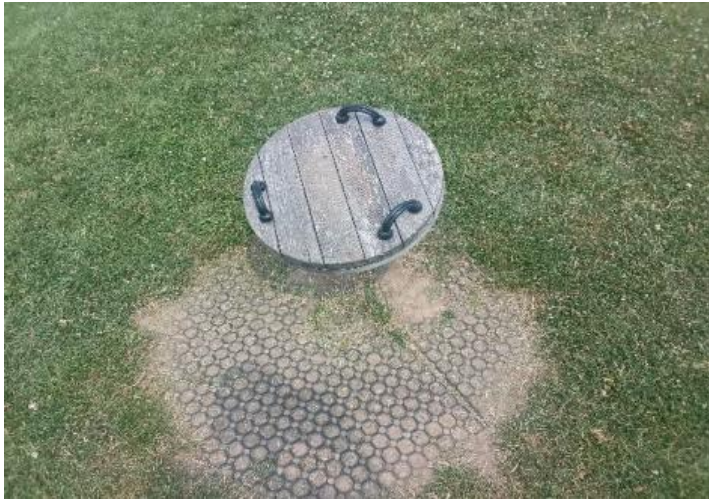
Item: Rotor Play - Spinner
Manufacturer: Kompan Ltd

Risk Level: V - Very Low Risk
Surface: Grass Matrix Tiles

Finding: There is/are inserts missing

Action: Replace missing inserts

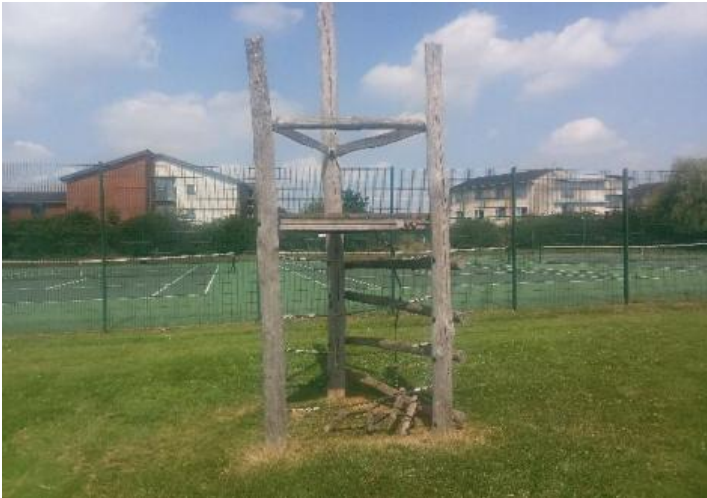
Item: Activity Equipment - Activity Platforms
Manufacturer: Kompan Ltd

Risk Level: L - Low Risk
Surface: Grass Matrix Tiles

Finding: A number of fixing(s) have worked loose

Action: Secure all loose fixings

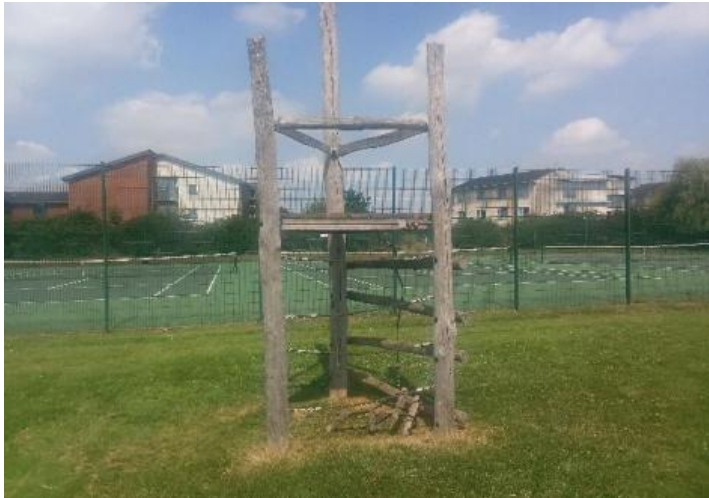
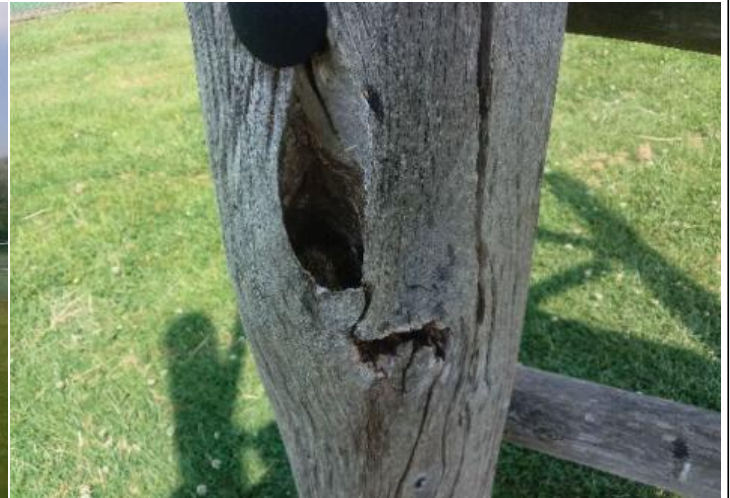
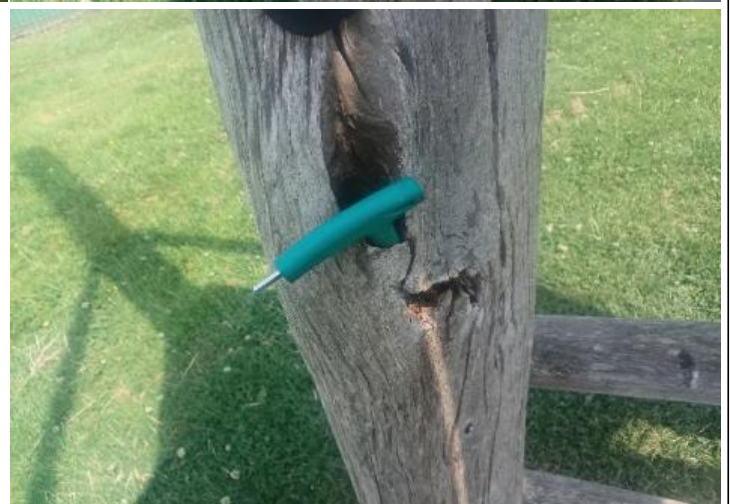
Item: Activity Equipment - Activity Platforms
Manufacturer: Kompan Ltd

Risk Level: L - Low Risk
Surface: Grass Matrix Tiles

Finding: They are very large cavities within the posts

Action: Refer to manufacturer

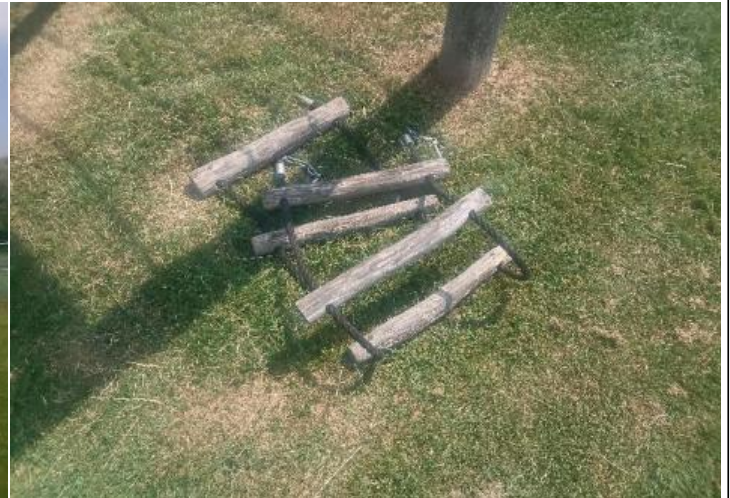
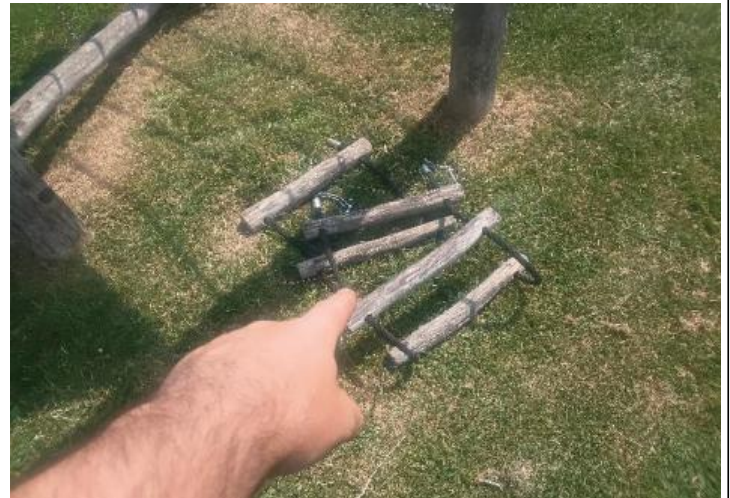
Item: Activity Equipment - Activity Platforms
Manufacturer: Kompan Ltd

Risk Level: L - Low Risk
Surface: Grass Matrix Tiles

Finding: The rope ladder fixings have sheared

Action: Reinstall the component

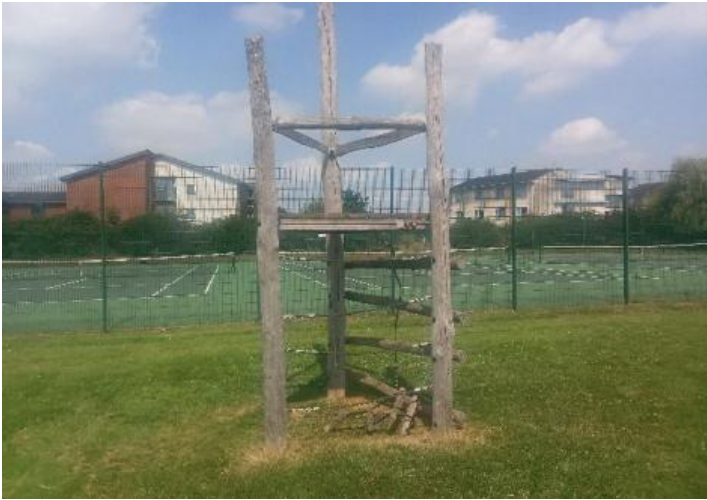
Item: Activity Equipment - Activity Platforms
Manufacturer: Kompan Ltd

Risk Level: L - Low Risk
Surface: Grass Matrix Tiles

Finding: A number of fixing(s) have worked loose

Action: Secure all loose fixings

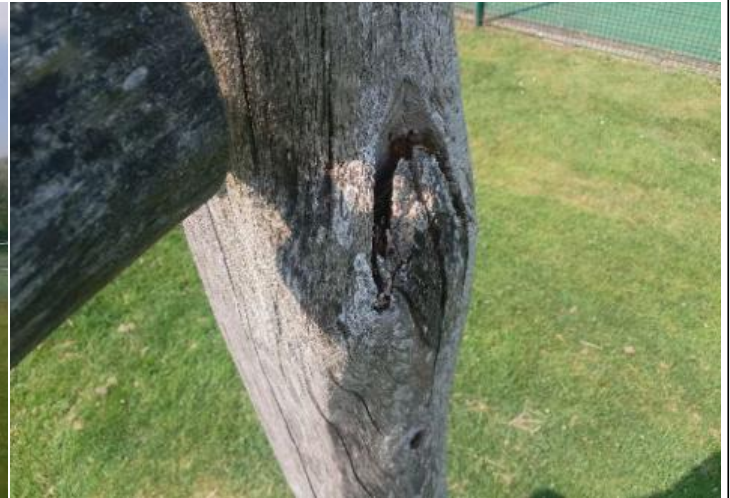
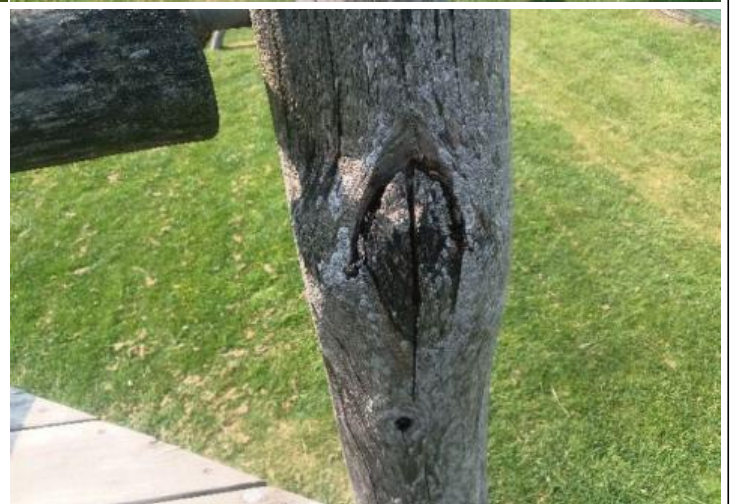
Item: Activity Equipment - Activity Platforms
Manufacturer: Kompan Ltd

Risk Level: L - Low Risk
Surface: Grass Matrix Tiles

Finding: Parts of the timber are rough or splintered

Action: Remove all rough or sharp edges

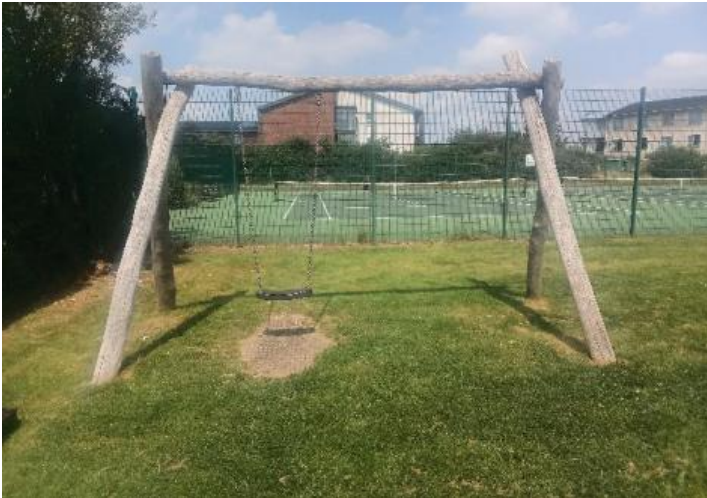
Item: Swings - 1 Bay 2 Seat (Flat)
Manufacturer: Kompan Ltd

Risk Level: N - Risk Assessment not Undertaken
Surface: Grass Matrix Tiles

Finding: The seat(s) and suspension were missing at the time of inspection and the inspector was unable to make a full compliance assessment

Action: Replace missing seat(s) and suspension

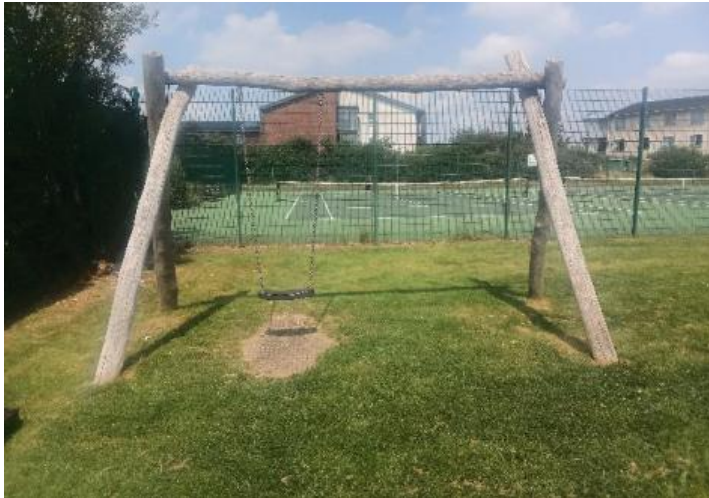
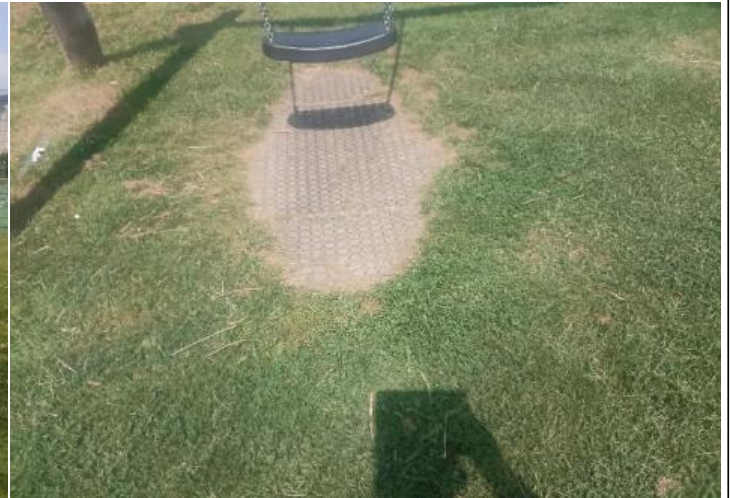
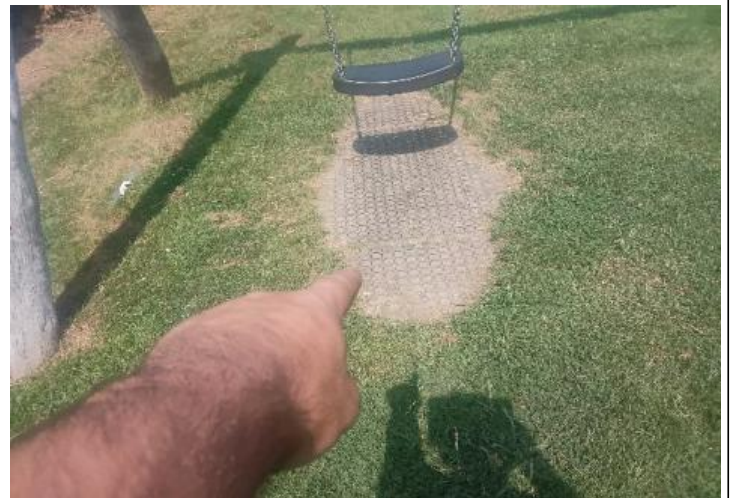
Item: Swings - 1 Bay 2 Seat (Flat)
Manufacturer: Kompan Ltd

Risk Level: L - Low Risk
Surface: Grass Matrix Tiles

Finding: The grass mats are silted up and the soil is compacted; this may have an effect on the impact absorbing properties of the surface. Consideration should be given to HIC testing the surface to verify impact attenuating properties (<https://playinspections.co.uk/inspection-services/safety-surface-testing/>)

Action: Contact our office for a quotation for this service

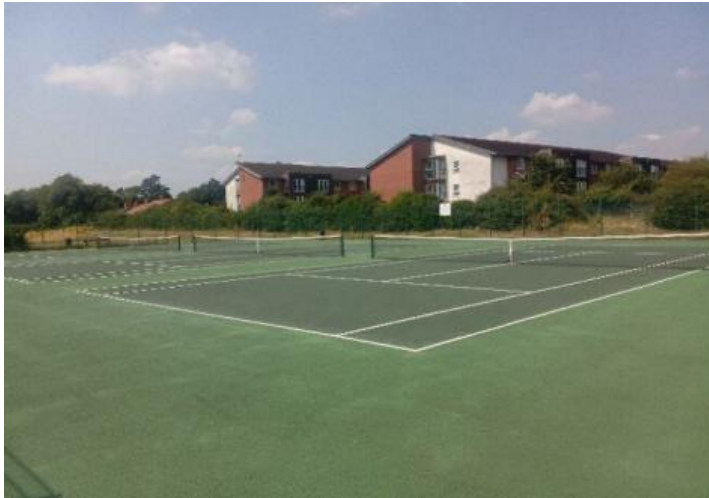
Item: Multi Use Games Area - Tennis Court
Manufacturer: Not Identified

Risk Level: V - Very Low Risk
Surface: Tarmac

Finding: A clearly visible facility sign should be provided in a prominent position with the wording as detailed BS EN 15312- the equipment is not intended for children less than 3 years old- the warning - Do not climb on the framework or nets- the warning - Do not hang on the ring (if provided)- the warning - Do not wear rings or other jewellery- name and telephone number of the administrator- number to call in case of accident

Action: Provide signage to BS EN 15312

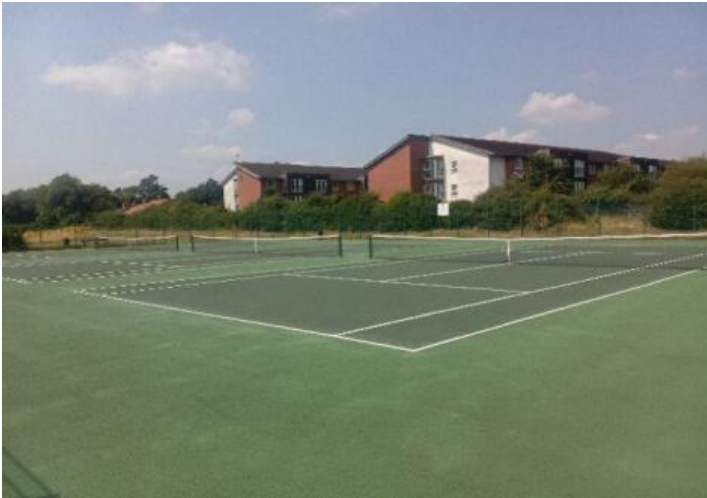
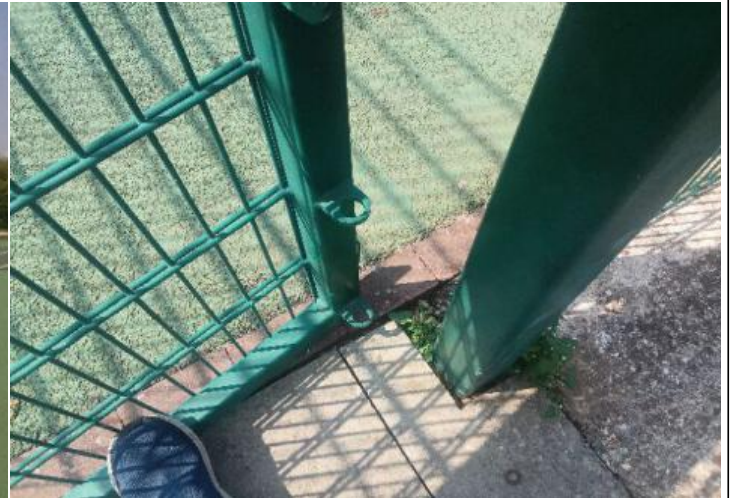
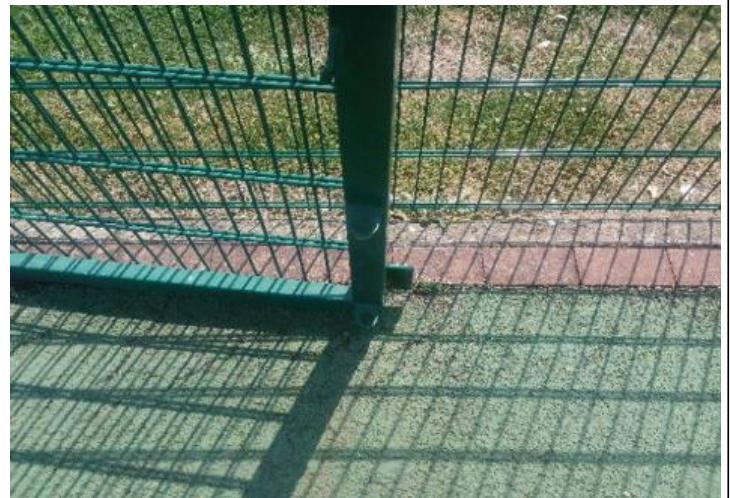
Item: Multi Use Games Area - Tennis Court
Manufacturer: Not Identified

Risk Level: L - Low Risk
Surface: Tarmac

Finding: The gate has no drop bolt sleeves and/or drop bolts fitted

Action: Provide drop bolt sleeves and/or drop bolts

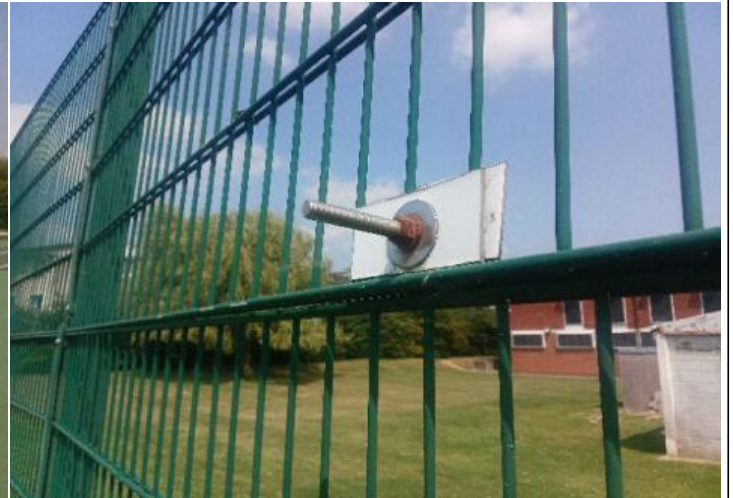
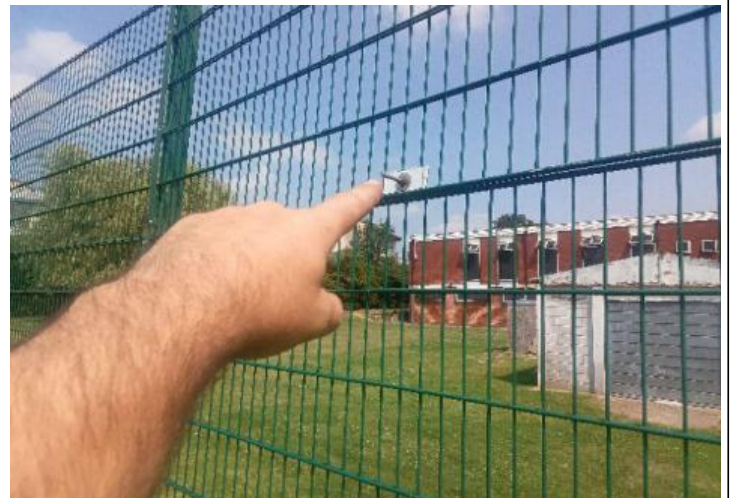
Item: Multi Use Games Area - Tennis Court
Manufacturer: Not Identified

Risk Level: L - Low Risk
Surface: Tarmac

Finding: There are projecting bolt thread(s) present

Action: Remove excess thread length and deburr or provide cap

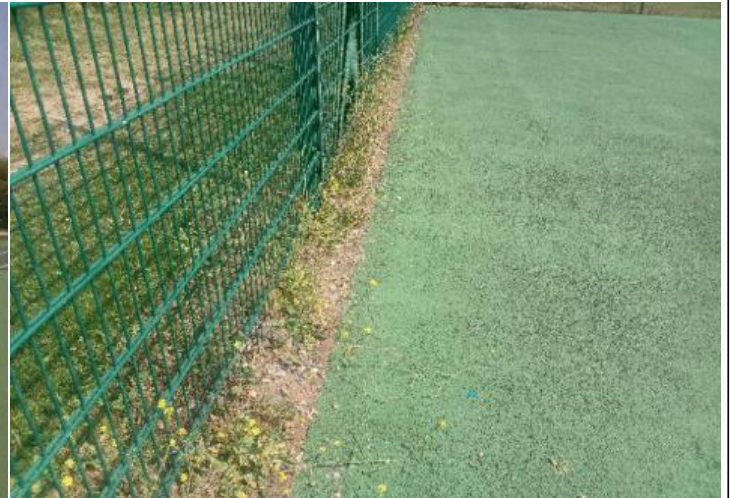
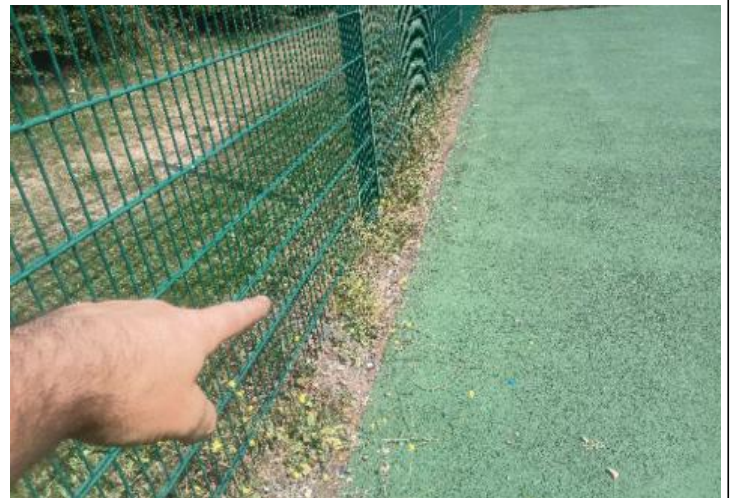
Item: Multi Use Games Area - Tennis Court
Manufacturer: Not Identified

Risk Level: L - Low Risk
Surface: Tarmac

Finding: There is weed / vegetation growth on, between, or around the edges of the surfacing
Action: Remove weed / vegetation growth

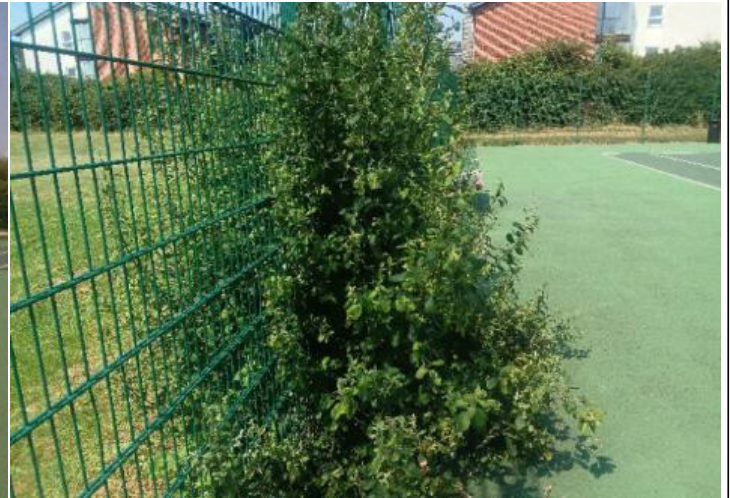
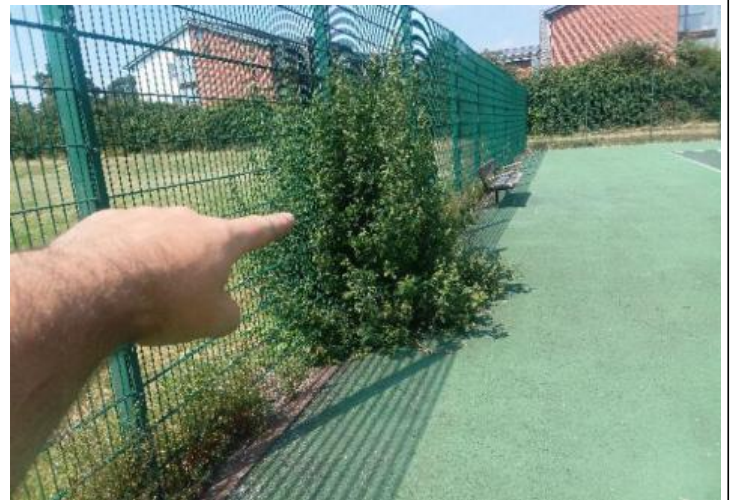
Item: Multi Use Games Area - Tennis Court
Manufacturer: Not Identified

Risk Level: L - Low Risk
Surface: Tarmac

Finding: The adjacent foliage is overhanging

Action: Cut back and maintain

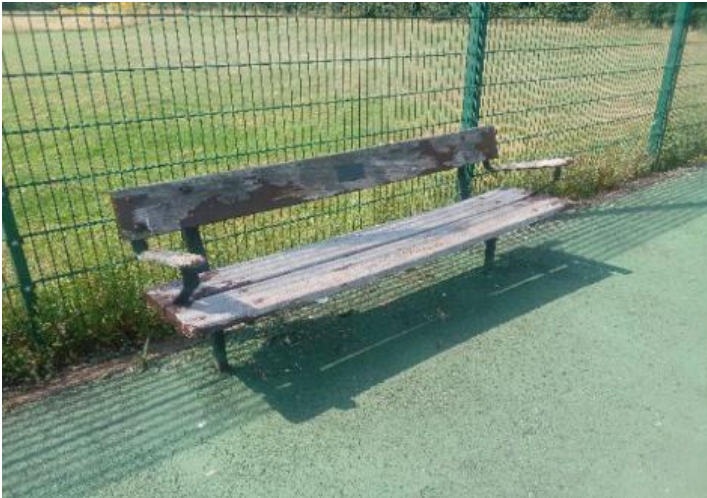
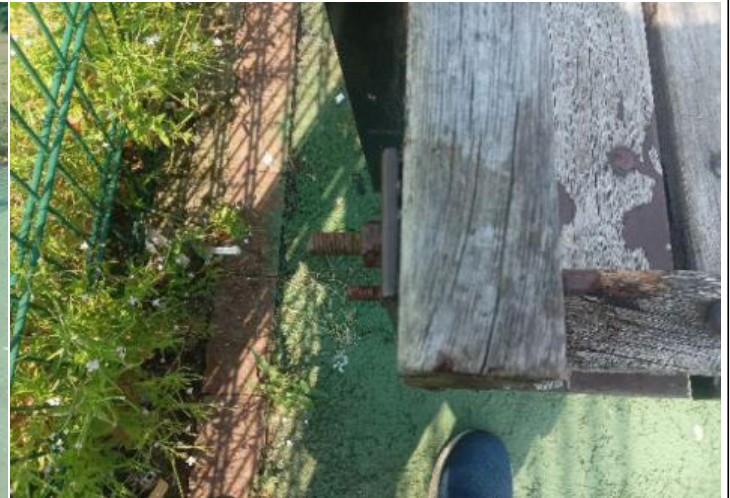
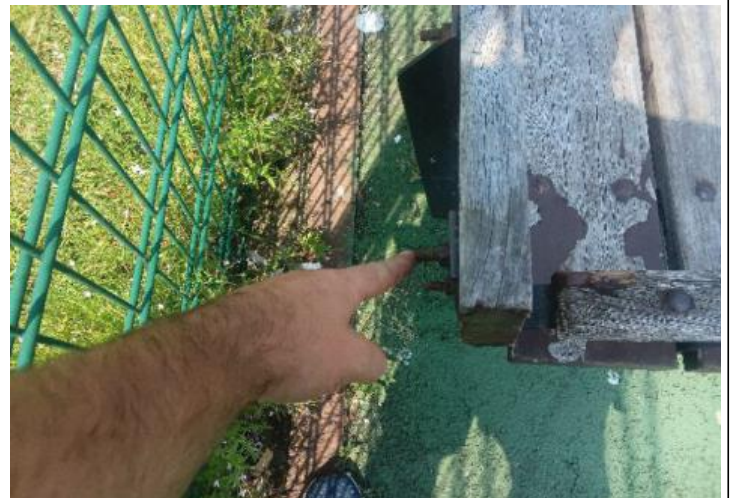
Item: Ancillary Items - Bench
Manufacturer: Not Identified

Risk Level: L - Low Risk
Surface: Tarmac

Finding: There are projecting bolt thread(s) present

Action: Remove excess thread length and deburr or provide cap

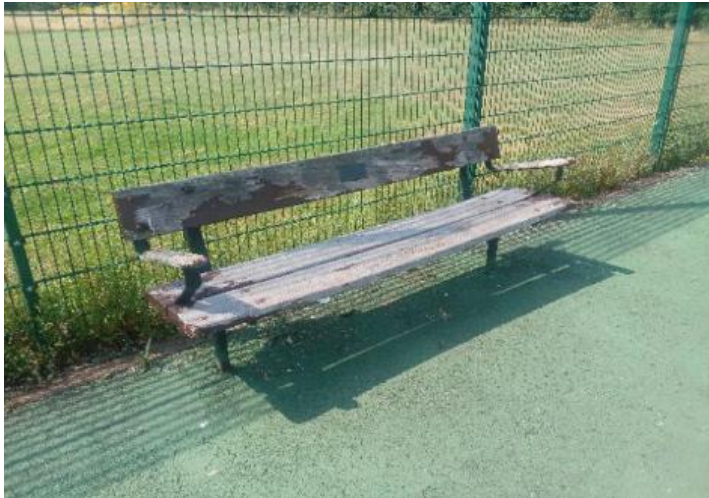
Item: Ancillary Items - Bench
Manufacturer: Not Identified

Risk Level: L - Low Risk
Surface: Tarmac

Finding: The timber stain is in poor condition

Action: Prepare all affected parts and re-stain with an appropriate preservative
