the **play inspection** company

Annual Inspection

Wexham Court Parish Council

Norway Drive Recreation Ground

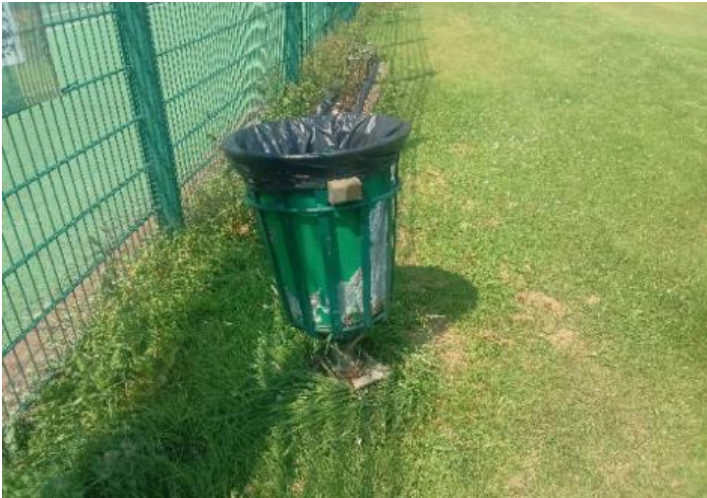
Item: Ancillary Items - Litter Bin
Manufacturer: Not Identified

Risk Level: L - Low Risk
Surface: Grass

Finding: The paintwork on this item has been damaged or worn exposing the metal underneath which is rusting / corroding

Action: Treat affected areas and repaint
